# STRUCTURAL AUDIT REPORT OF

## CHANDRA BHUVAN CO-OP HSG. SOCIETY Chandralok-A, 97, Nepean Road, Mumbai 400026

**A. D. SHINTRE CONSULTANS**  
ARCHITECTS & CONSULTING ENGINEERS

12.12.2019

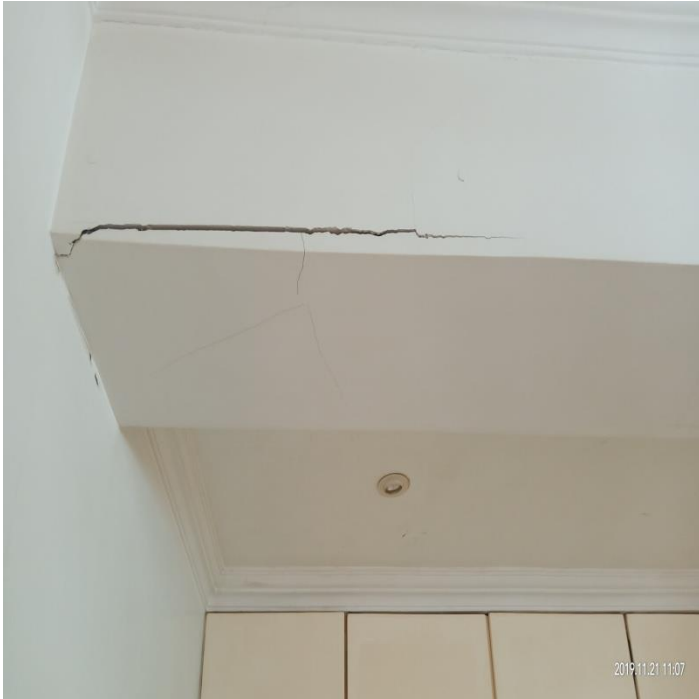
**Flat No.503: Cracks on living room column**

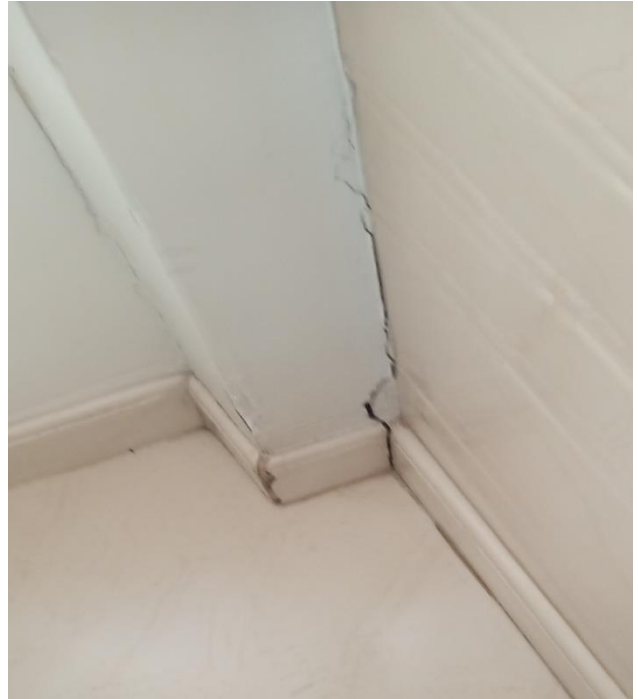
**Flat No. 503: cracks on beam bottom at bedroom-3**

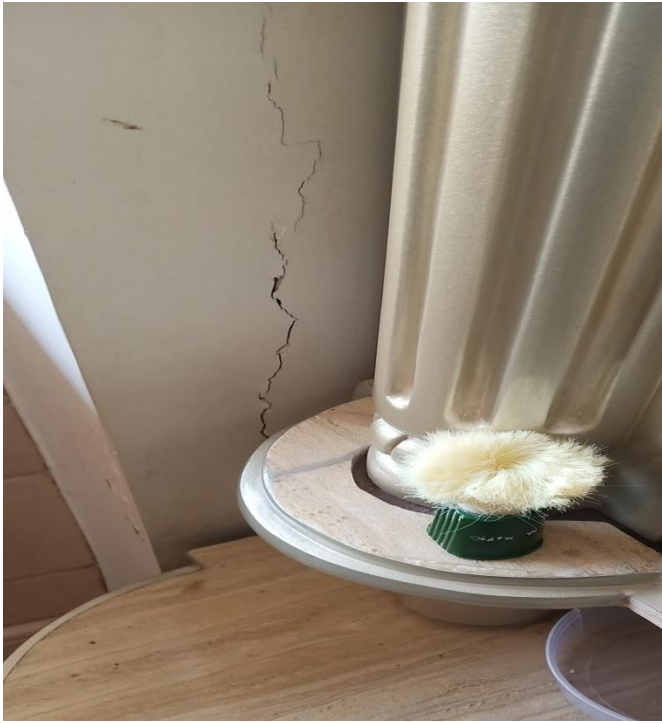
**Flat No.503: Cracks on column at bedroom-2**

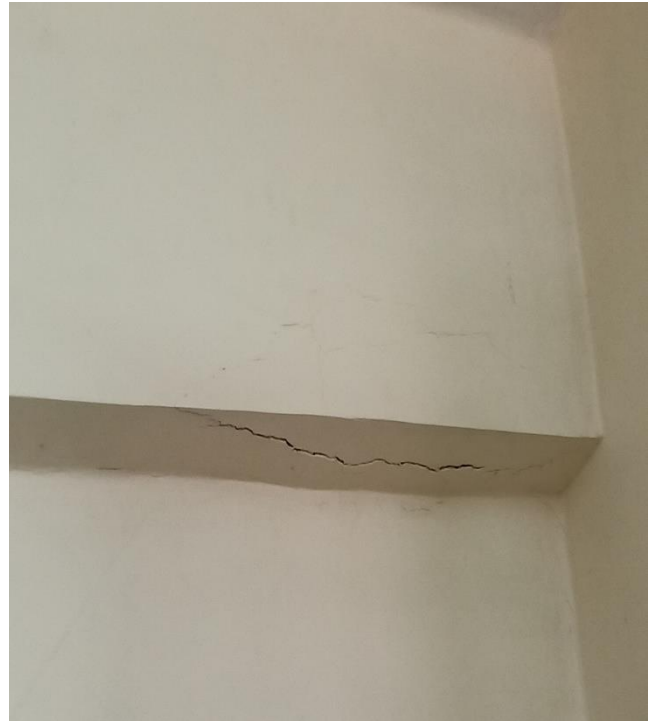
**Flat No.503: Cracks on column at bedroom-2**

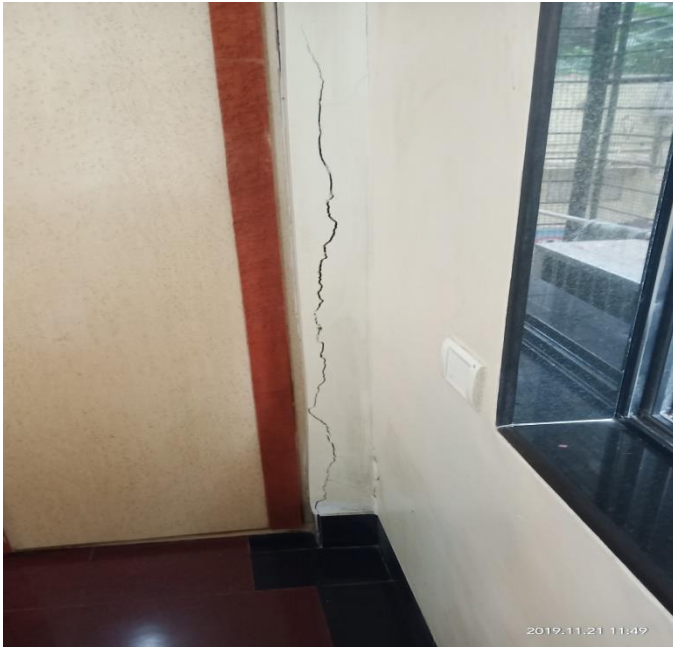
**Flat No. 110: Cracks on on column at bedroom**

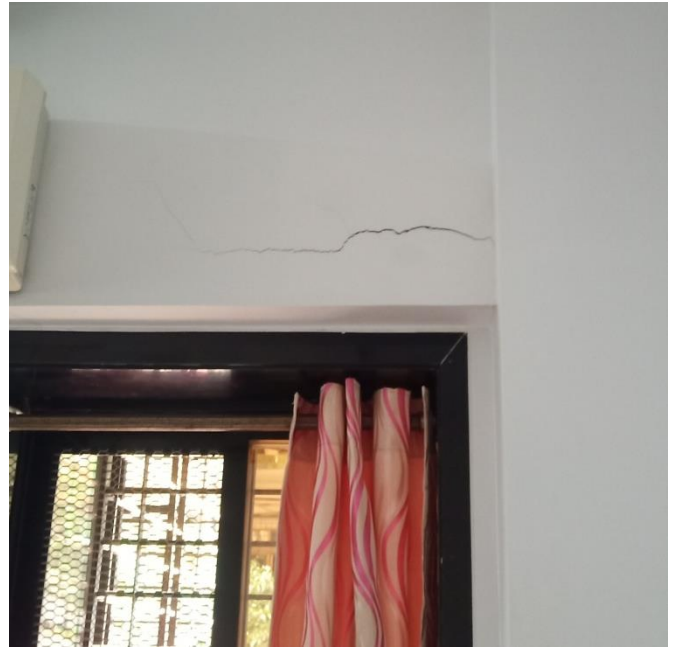
**Flat No. 110: Cracks on column at bedroom**

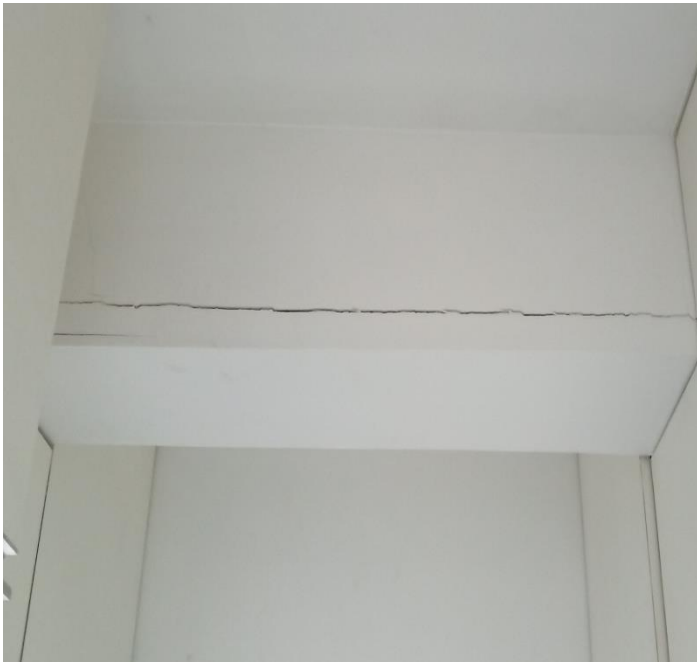
**Flat No. 107: Cracks on beam at bedroom**

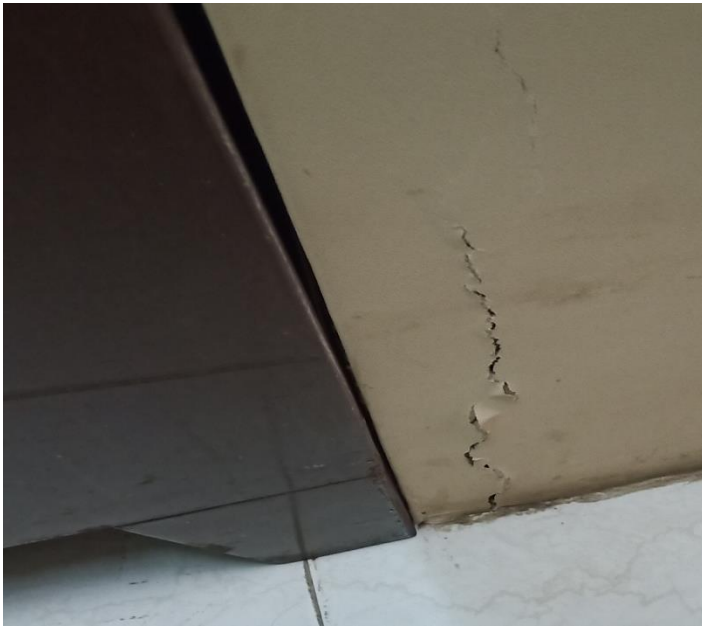
**Flat No. 105: Leakages marks on wall at bedroom-2**

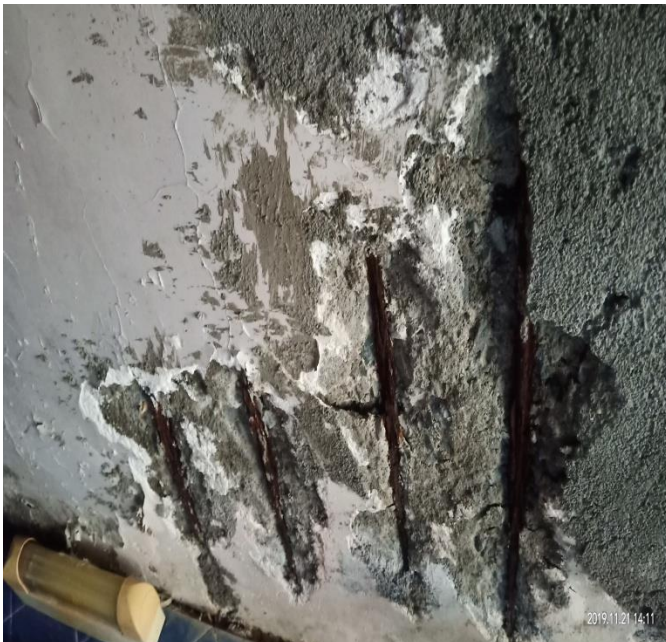
**Flat No. 205: Wide cracks on column at bedroom -3**

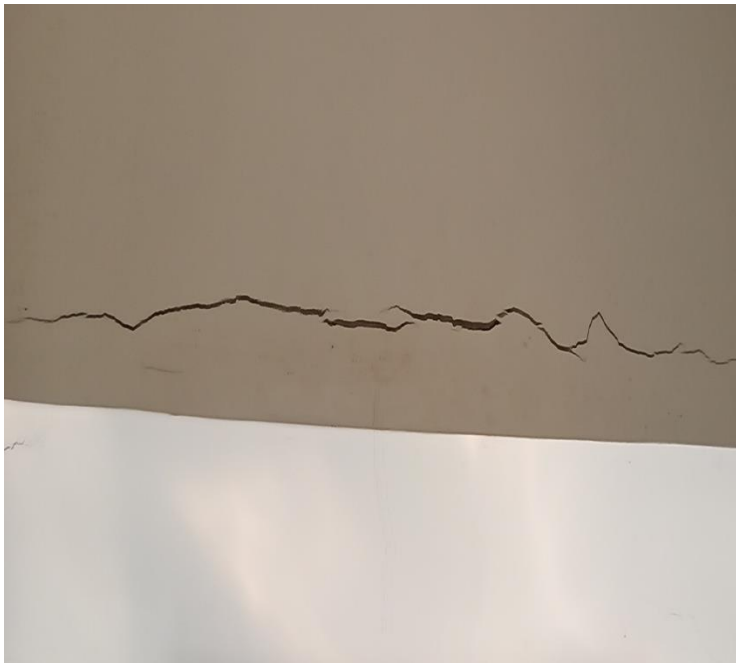
**Flat No. 205: Wide cracks on column at livingroom**

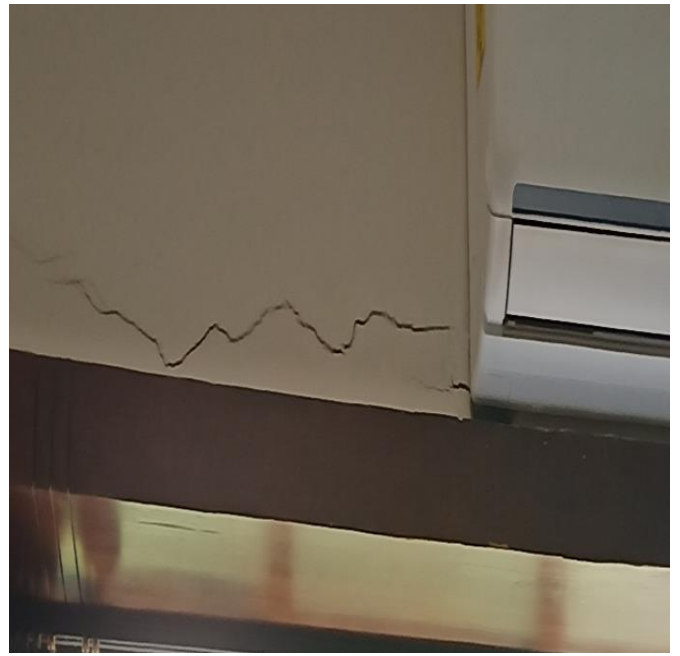
**Flat No. 311: Wide cracks on beam at kitchen**

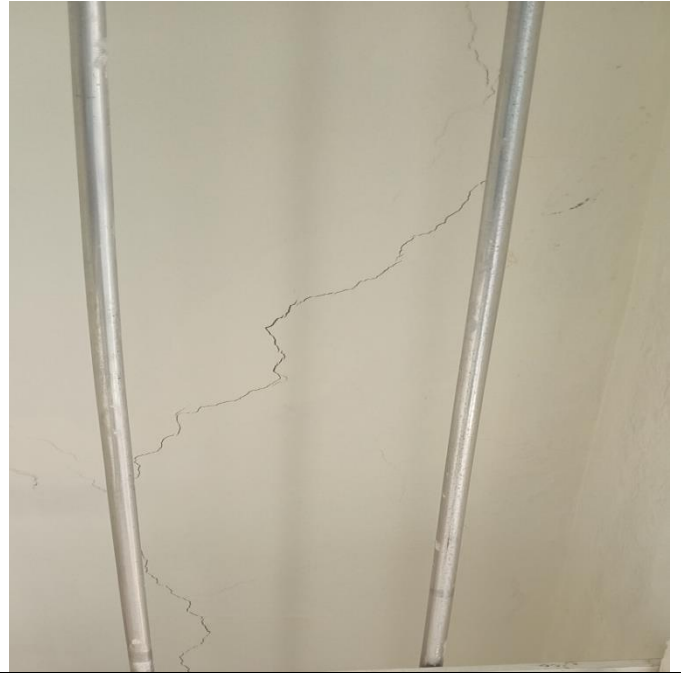
**Flat No. 207: cracks on column**

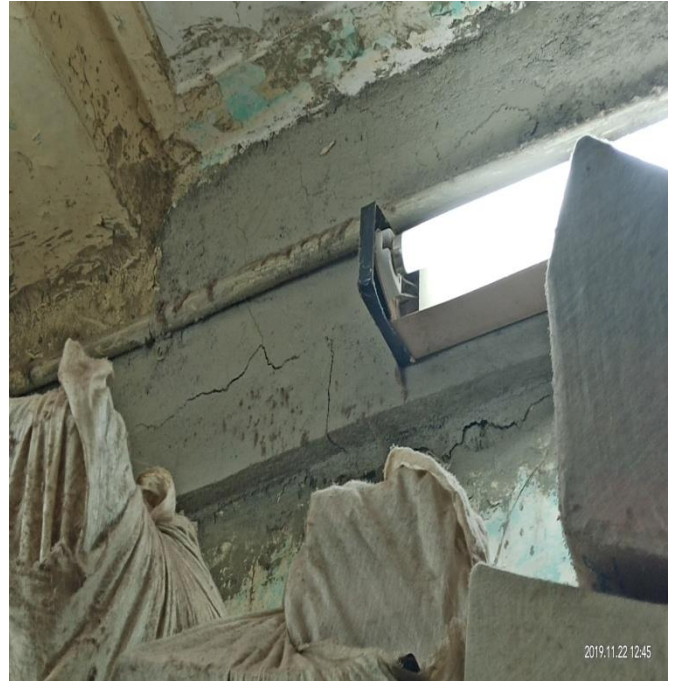
**Flat No. 306: Tiles cracks on column at bathroom**

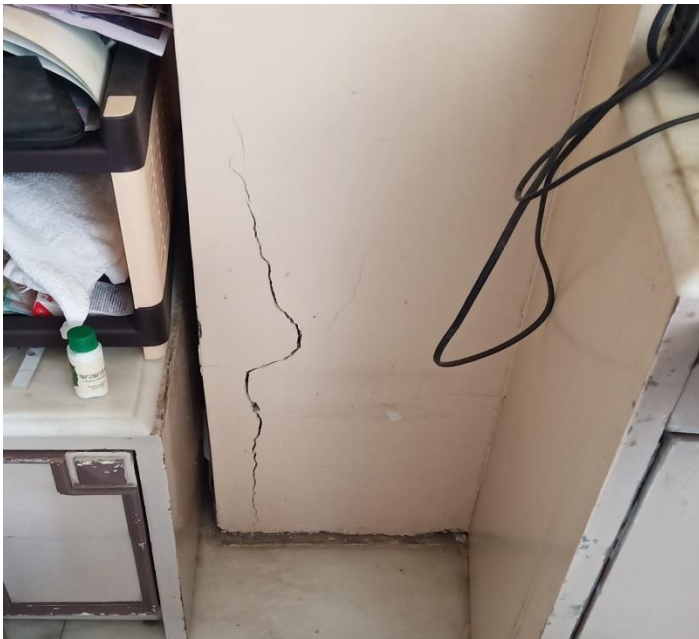
**Flat No. 401A: vertical cracks on column at living room**

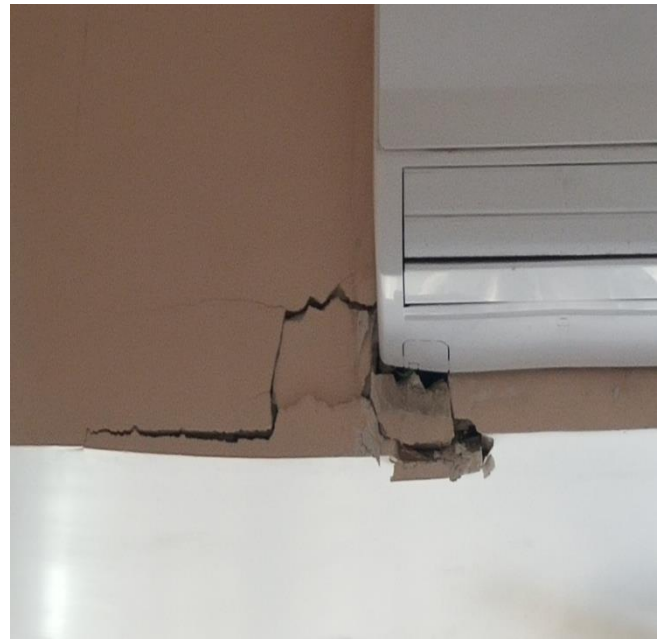
**Flat No. 401A: wide cracks on column at bedroom-2**

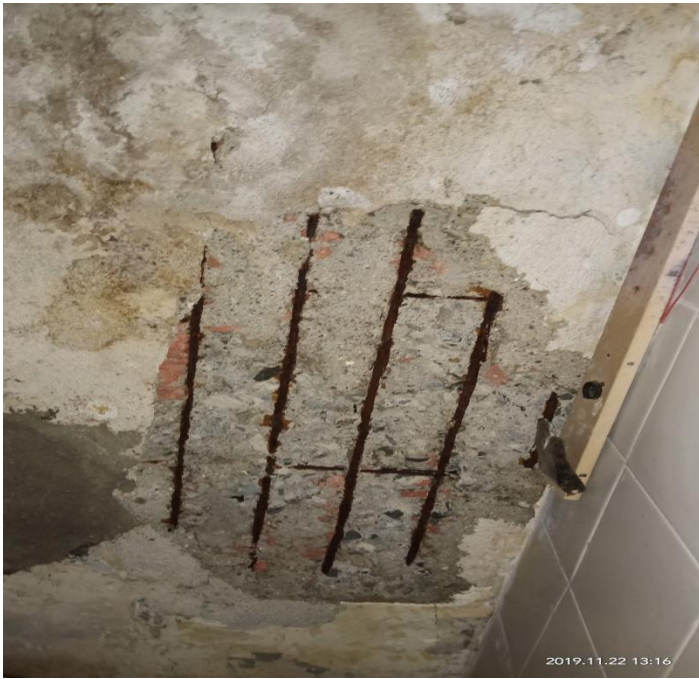
**Flat No. 401A: cracks on beam at bedroom-2**

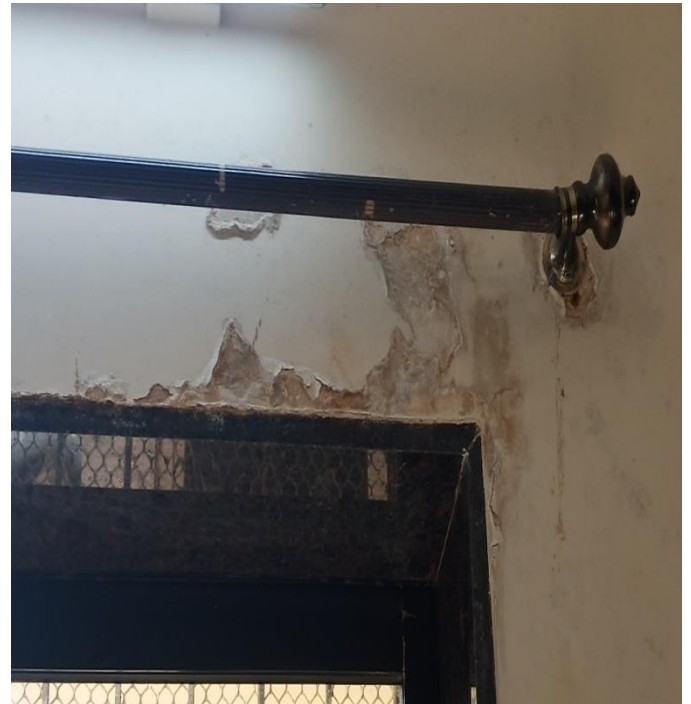
**Flat No. 409: cracks on beam**

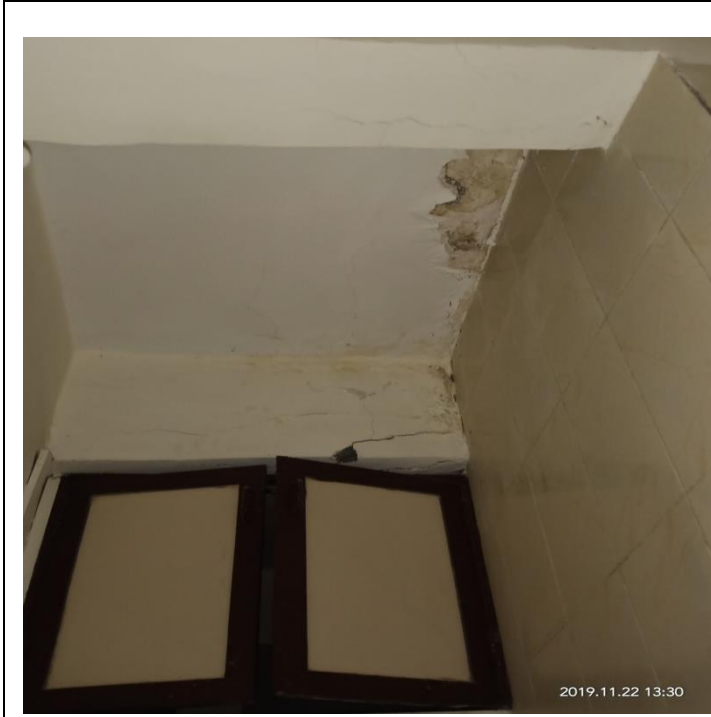
**Flat No. 410: major leakage marks on external wall**

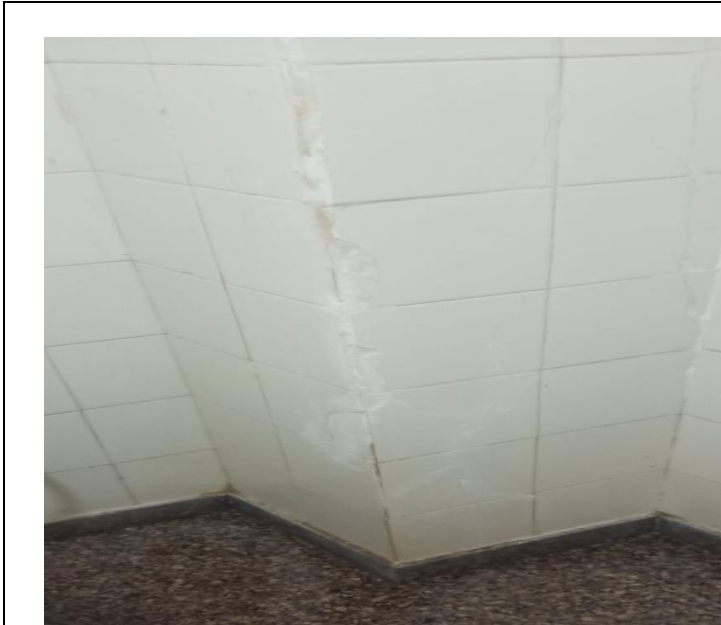
**Flat No. 403: Cracks on column at living room**

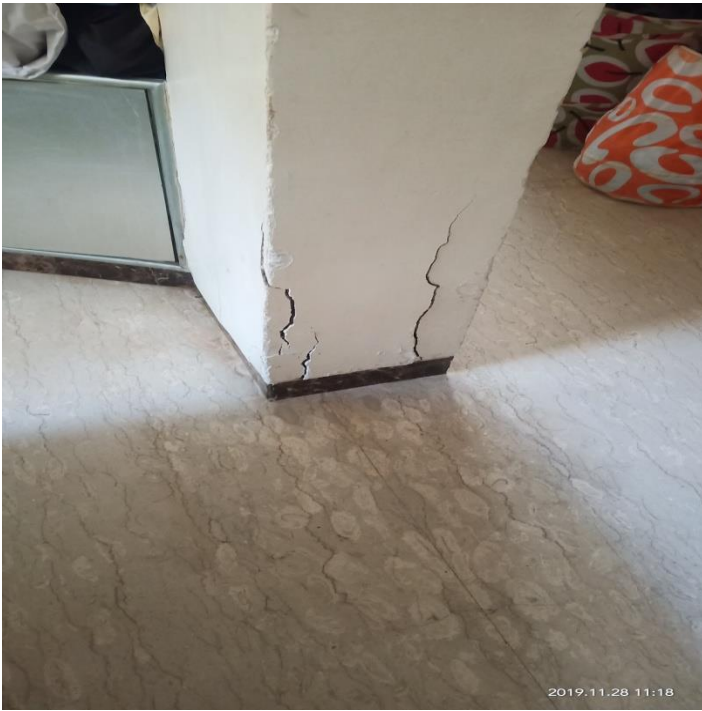
**Flat No.502: wide cracks on column at bedroom-1**

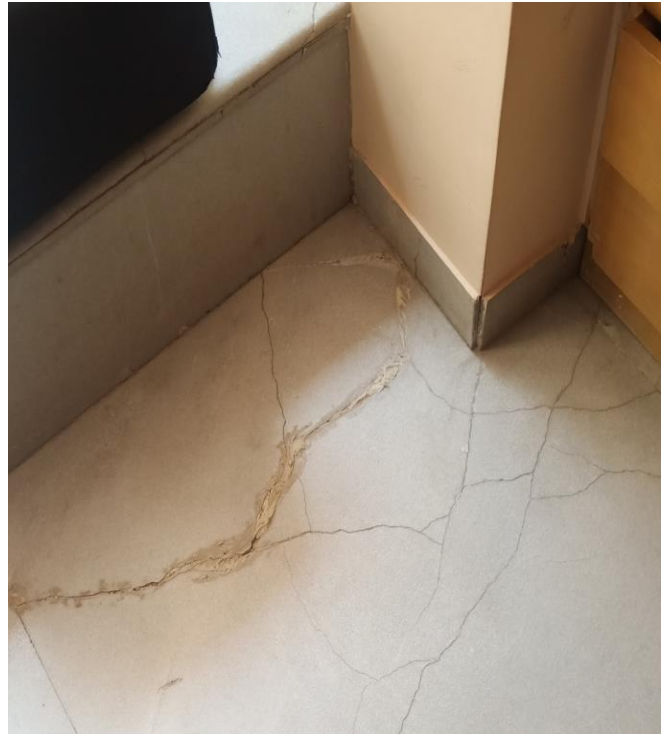
**Flat No.509: cracks on floor tiles/stone**

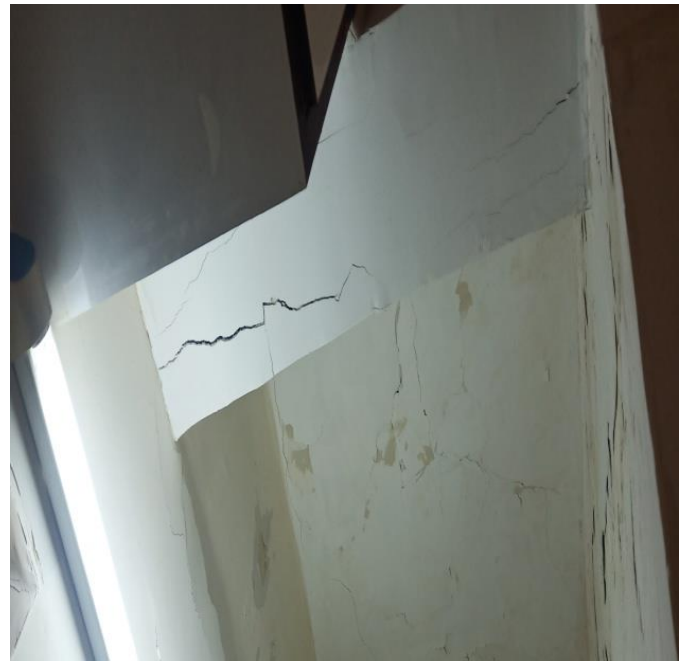
**Flat No.508: cracks on beam bottom**

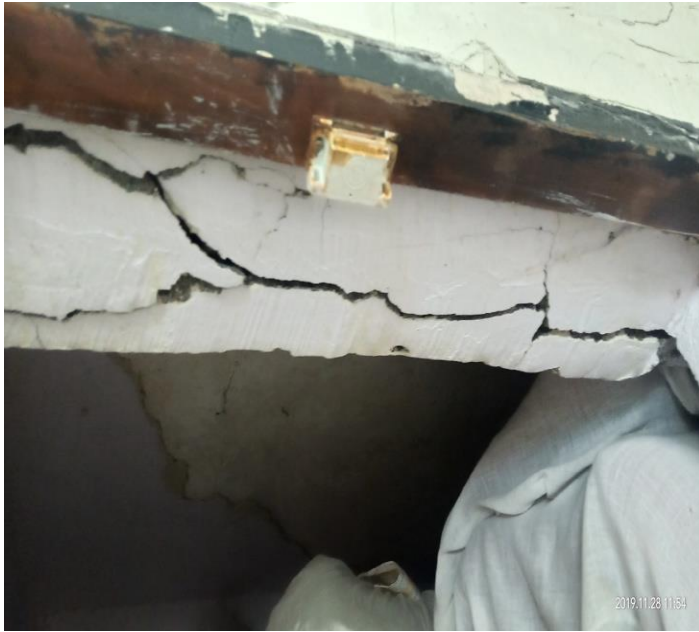
**Flat No.508: cracks on beam bottom**

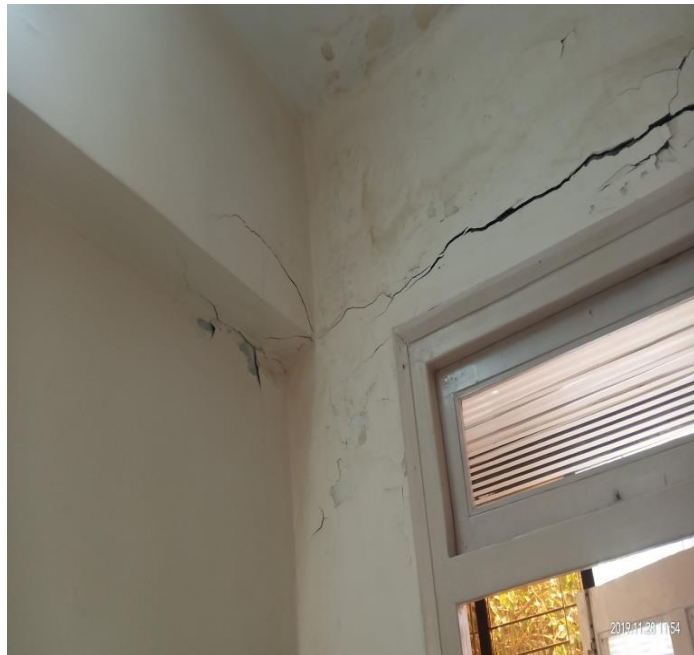
**Flat No.508: cracks on beam bottom**

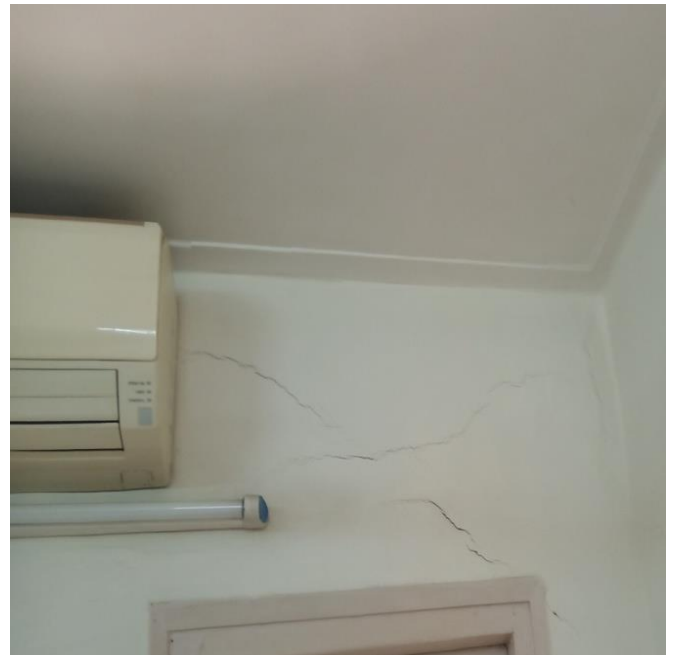
**Flat No.508: cracks on beam bottom**

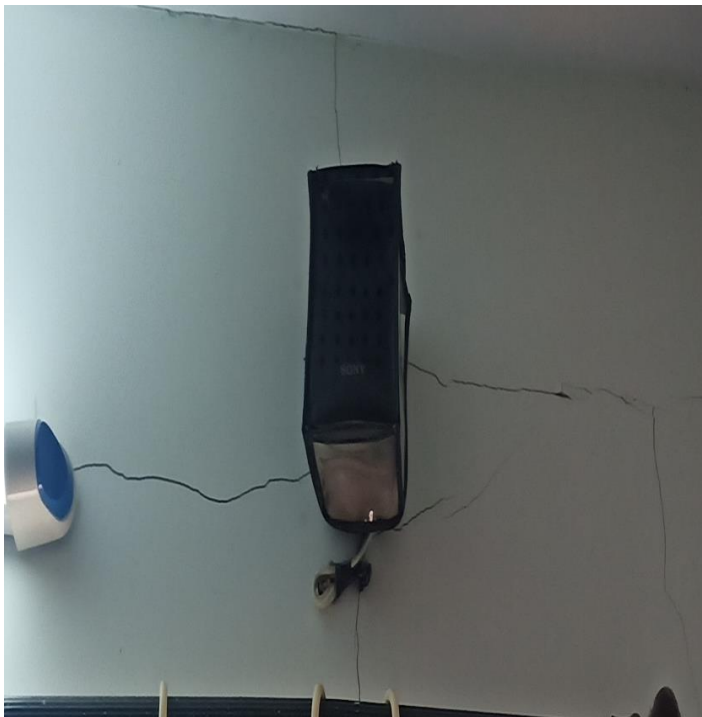
**Flat No.506: cracks on beam bottom**

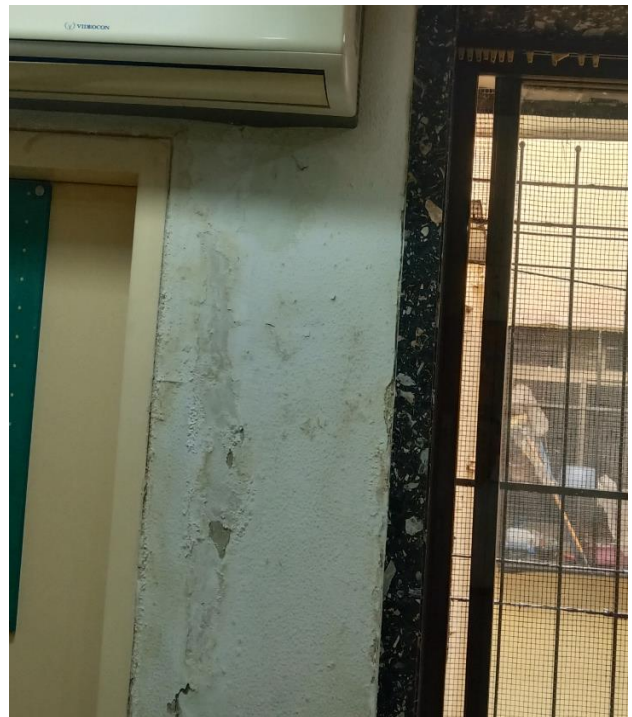
**Flat No.505: cracks on beam at bedroom-1**

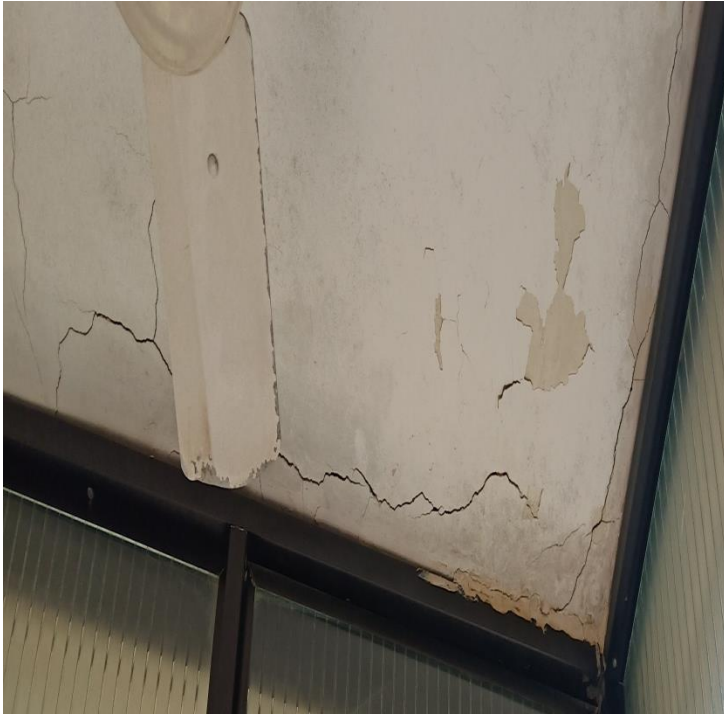
**Flat No.408: leakage marks on chowk side wall**

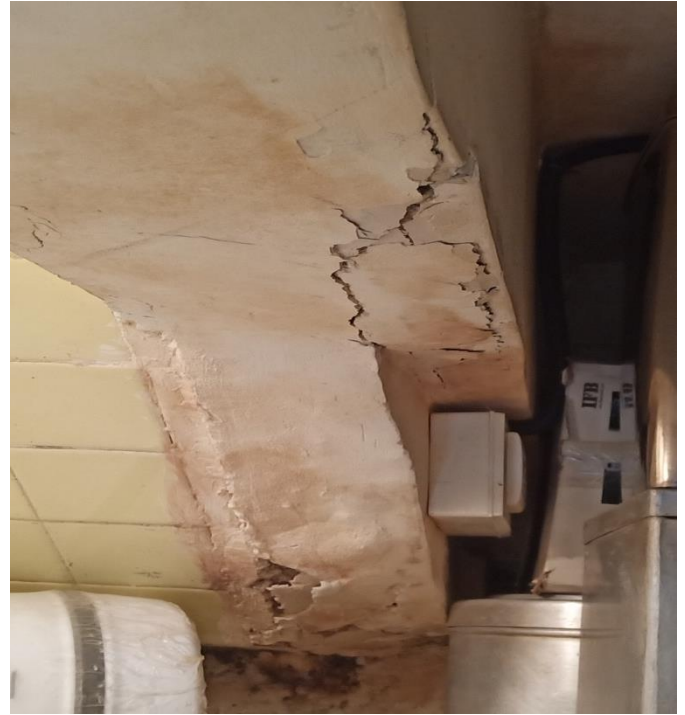
**Flat No.408: cracks on ceiling**

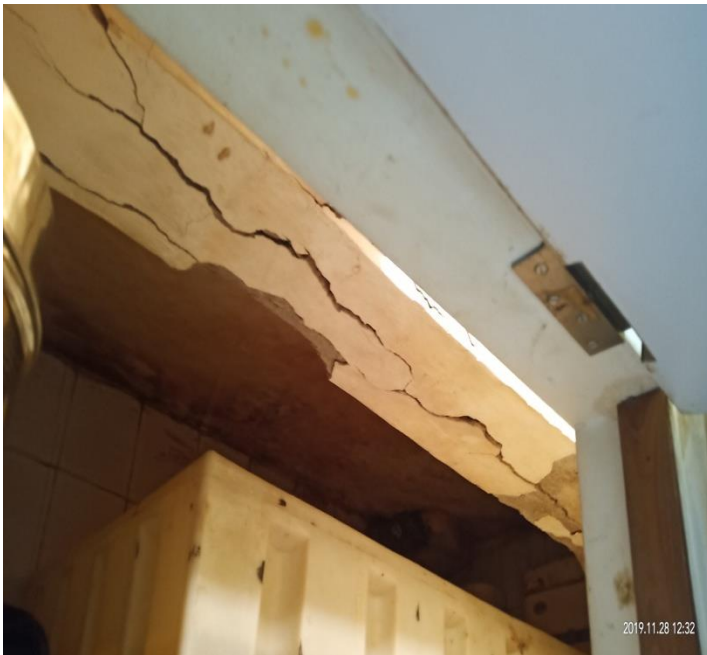
**Flat No.408: cracks on beam**

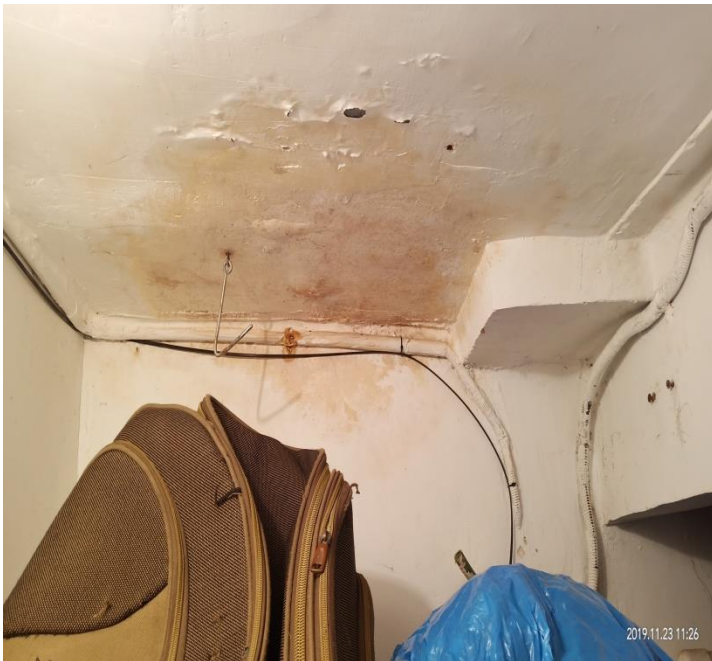
**Flat No.408: cracks on ceiling**

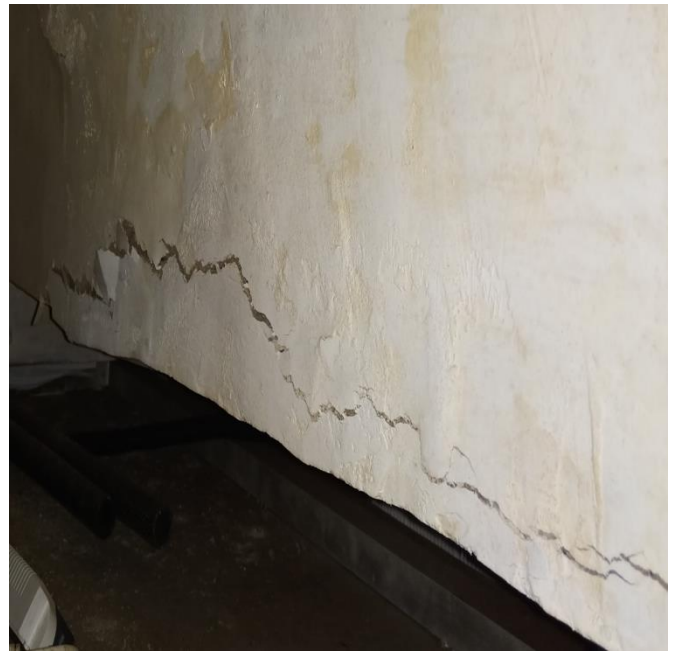
**Shop No. 2: Leakage marks on ceiling**

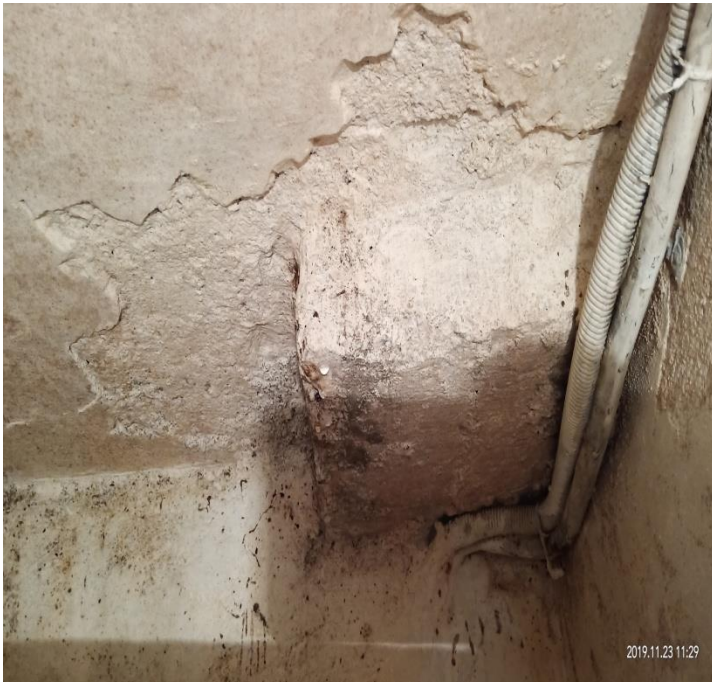
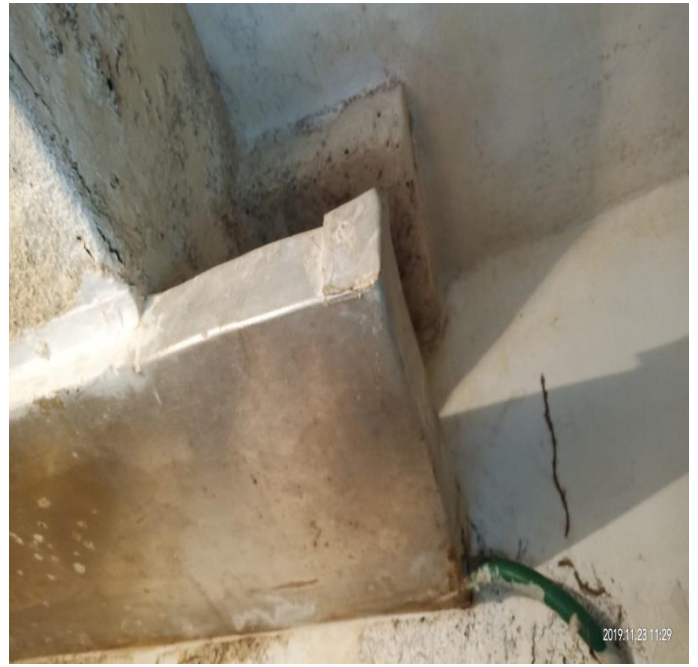
**Shop No. 3: Wide cracks on RRC Beam**

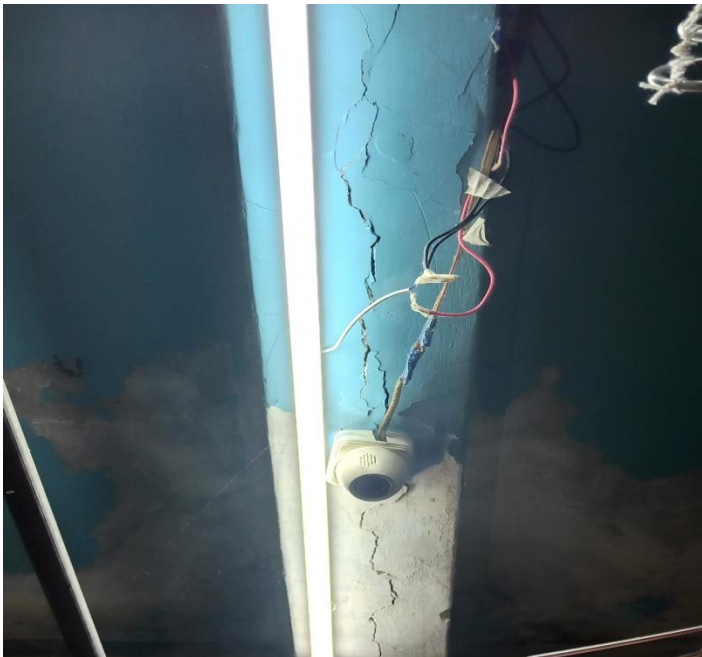
**Shop No. 3: Leakage marks on ceiling and try fixed on ceiling for avoid leakage**

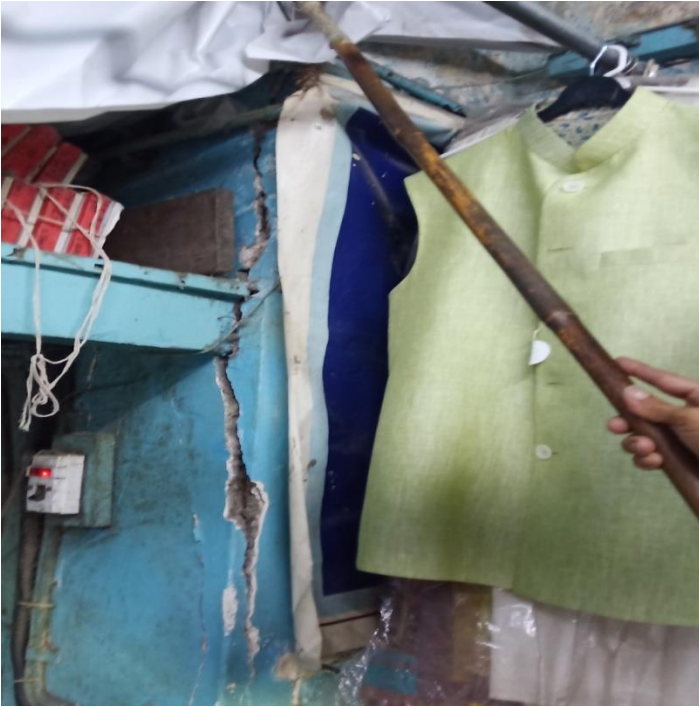
**Shop-4: bulging of concrete on ceiling, column and beam**

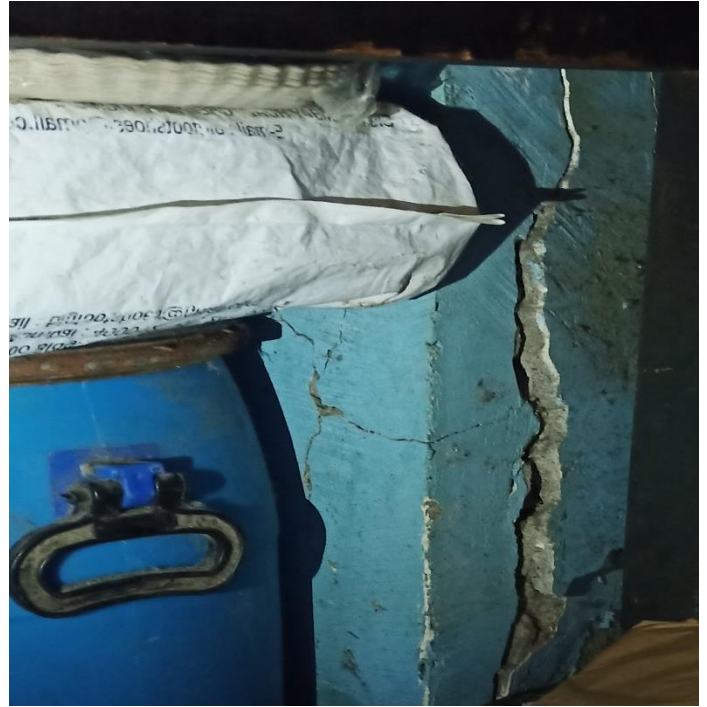
**Shop-4: wide cracks on column and bulging of concrete**

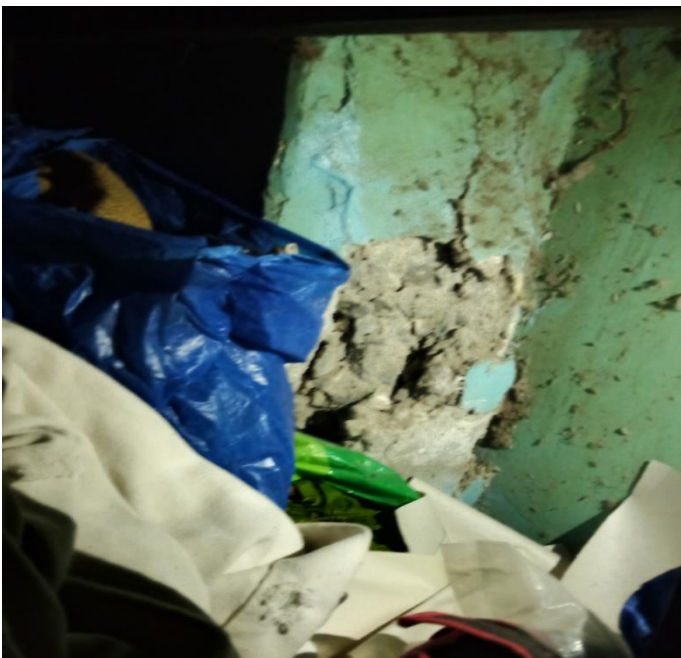
**Shop-4: wide cracks on column and bulging of concrete**

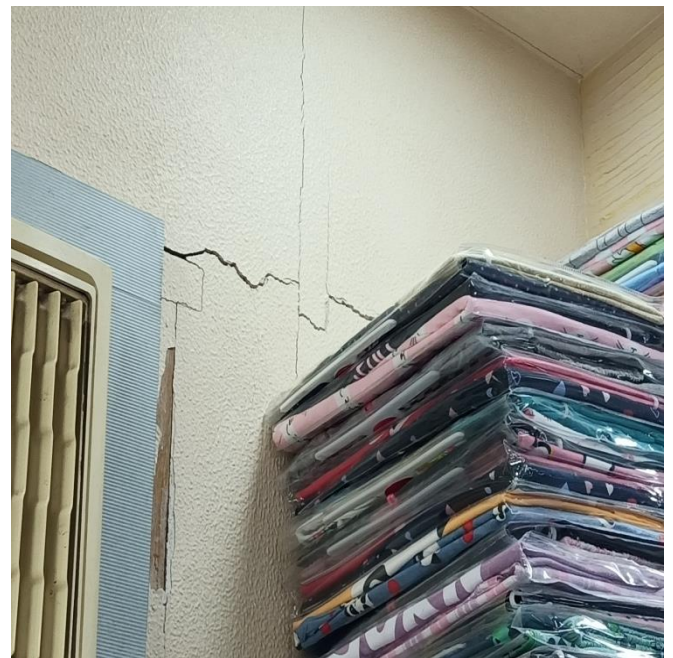
**Shop-4: bulging of concrete on ceiling, column and beam**

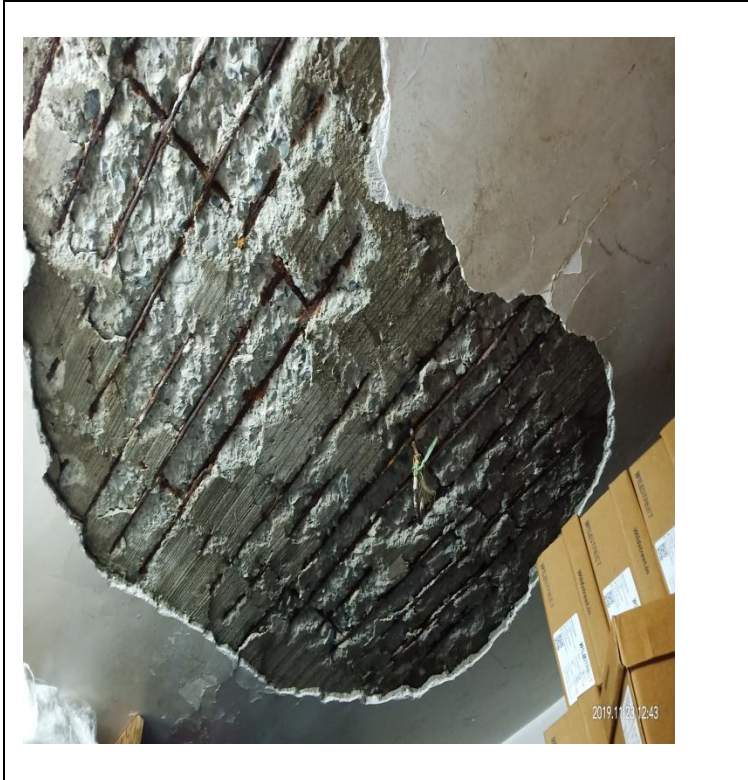
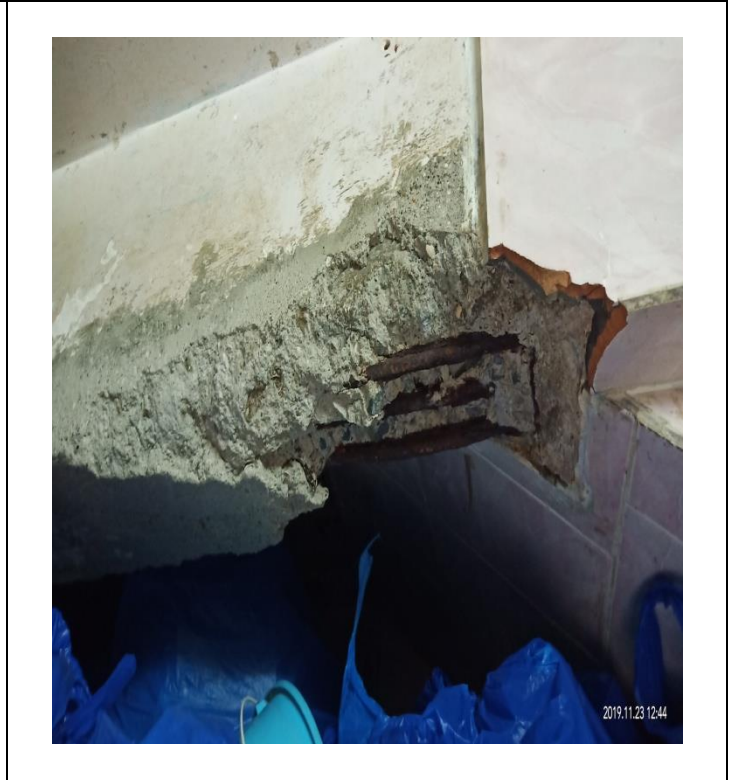
**Shop-16: cracks on beam**

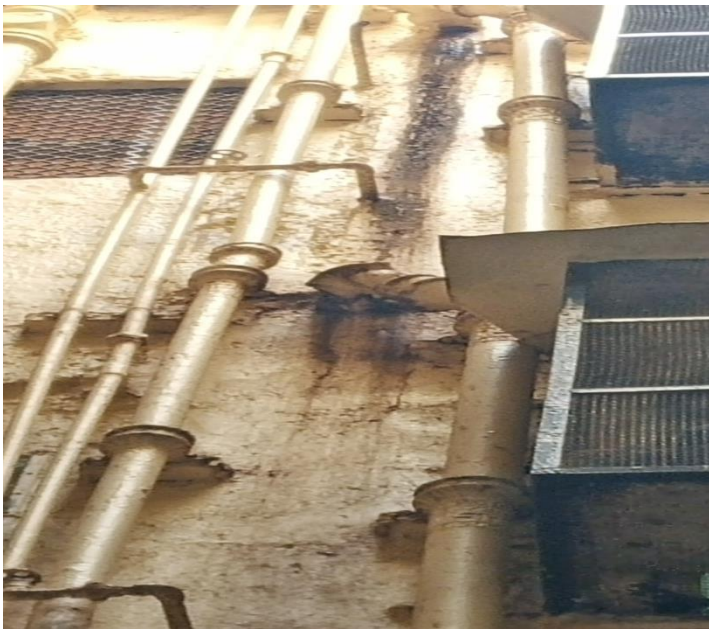
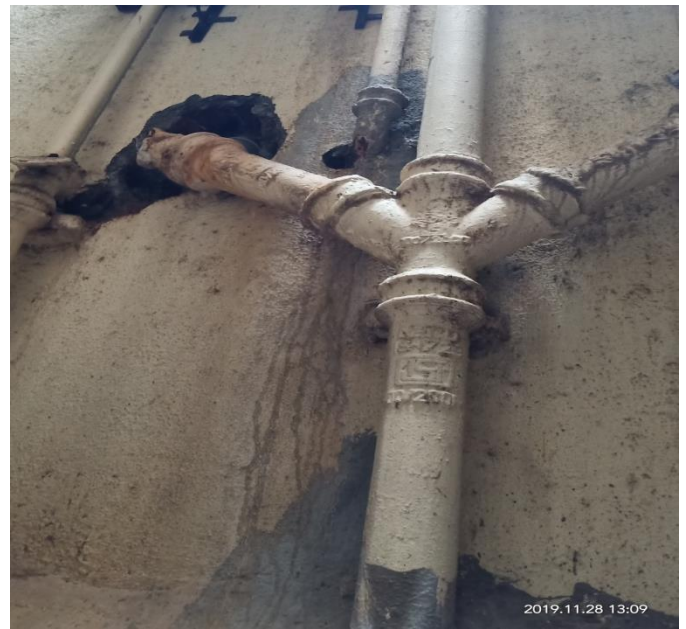
**Water proofing coating on 5<sup>th</sup> floor level balcony top.**

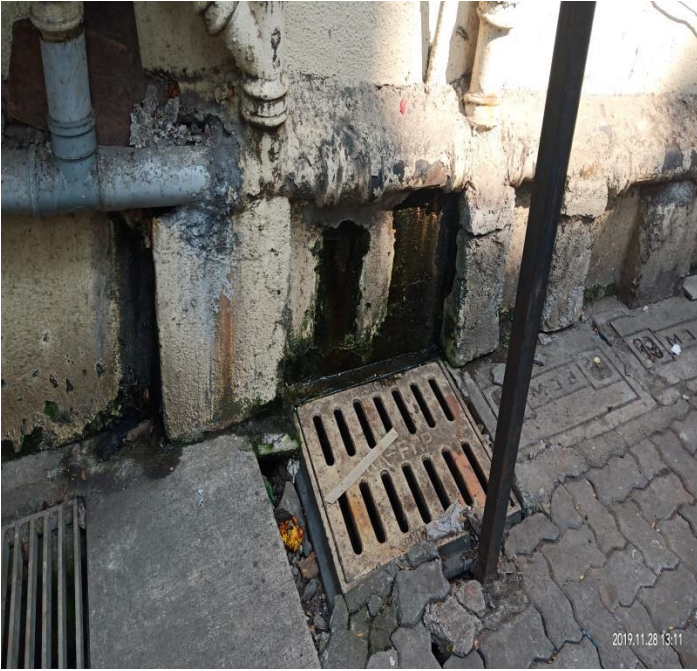
**Open on Plumbing Gabada**
