Structural Stability Report Prepared for SBI / RACPC Andheri (East)/ Mr. Tejraj R. Devadiga (011100/2308087)

Vastu/Mumbai/09/2024/011100/2308087

### Structural Stability Report

Structural Observation Report of Residential Flat No. 401, 4<sup>th</sup> Floor, "Evershine Sapphire Co-Op. Hsg. Soc. Ltd", Chandivali Farm Road, Saki Vihar Road, Andheri (East), Mumbai - 400 072, State - Maharashtra, India.

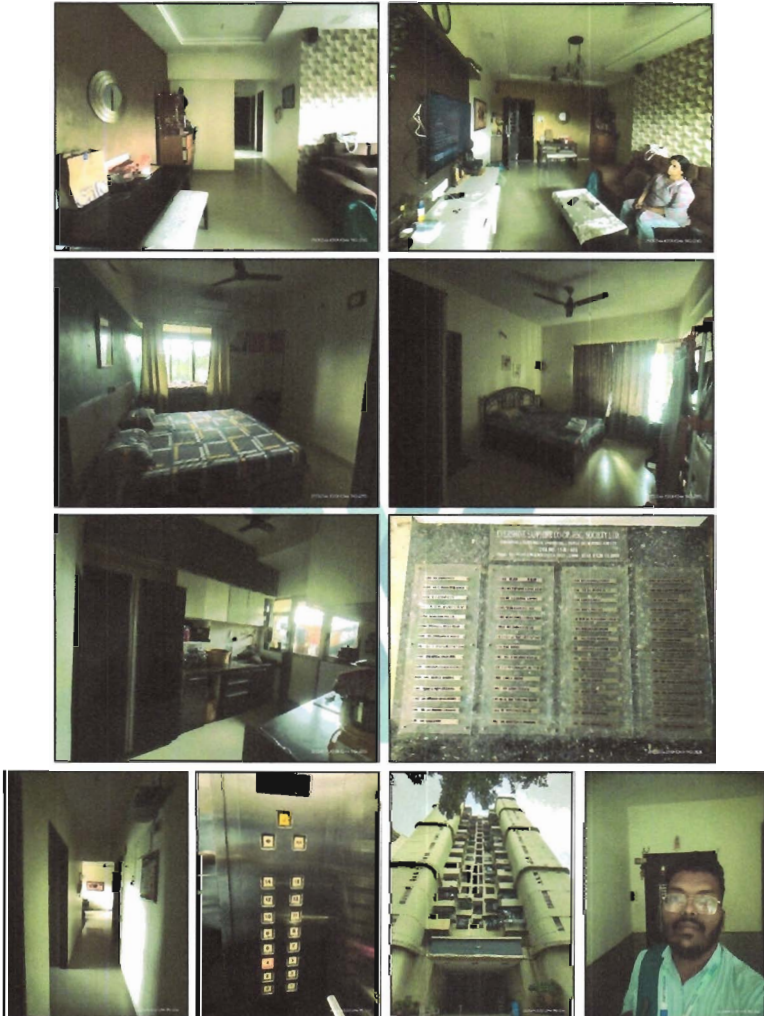
### Actual site photographs
