STRUCTURAL AUDIT REPORT FOR
FAROHAR CO.HSG.SOC.LTD,
DOSSABHOY MANSION, 796, JAME JAMSHED
ROAD, DADAR (E), MUMBAI- 400-014.

PHOTOGRAPHIC
EVENTS FOR LEAKAGE &
STRUCTURAL DAMAGE

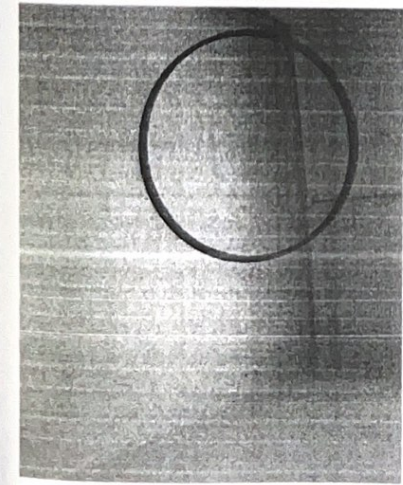
5.B- CEILING SHOWS CRACKS & CRAZING.

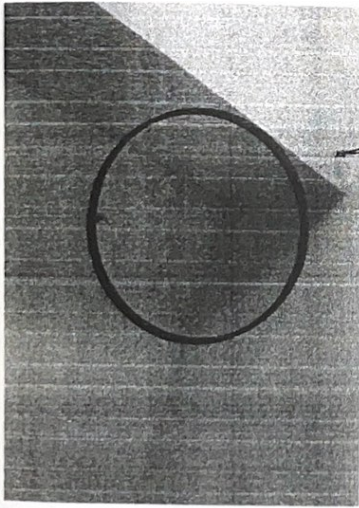
5B- CEILING AT CORNER SHOWS DRY SEEPAGE.

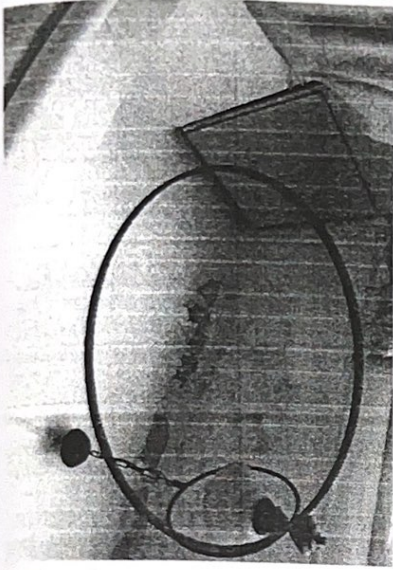
5B- DRY SEEPAGE & PAINT PEELING IN CEILING FROM EXTERNAL.

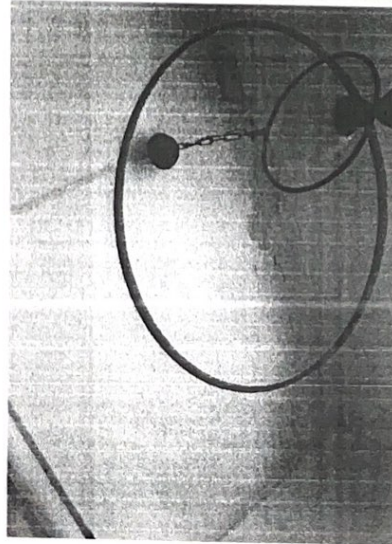
5.B- DRY SEEPAGE & PAINT PEELING IN CEILING FROM EXTERNAL.

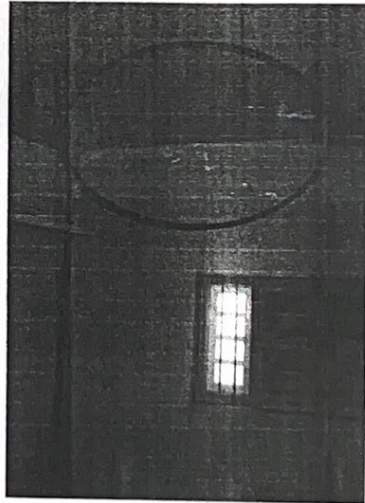
2. B- LOAD BEARING MASONRY WALLS SHOWS EXTERNAL SEEPAGE.

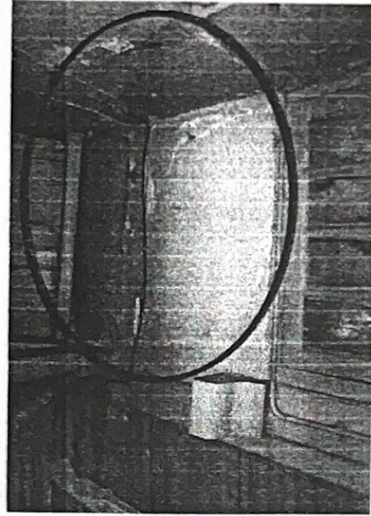
2.B- LOAD BEARING MASONRY WALLS SHOWS EXTERNAL SEEPAGE.

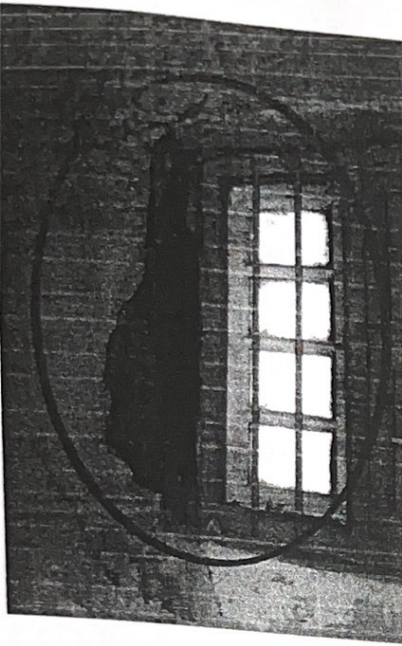
2. B- SEVERE STEEL EXPOSED AT R.C.C BEAM IS OBSERVED.

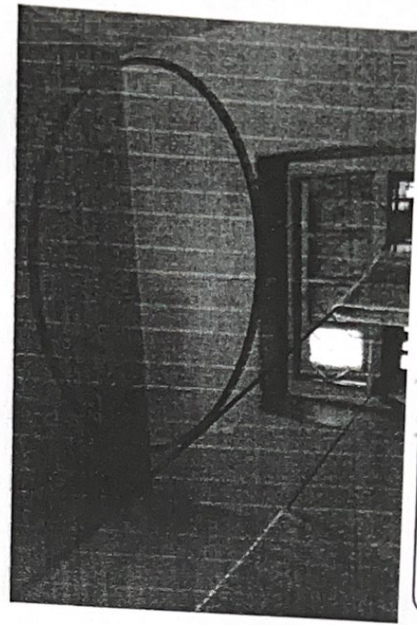
1.B- VERICAL CRACK ON LOAD BEARING WALL MASONRY IS OBSERVED.

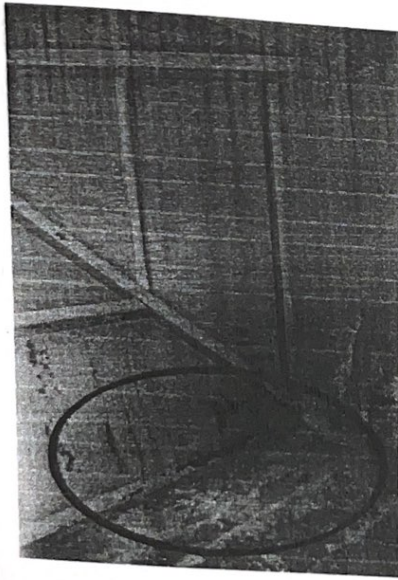
2.B- EXTERNAL SEEPAGE FROM ROOF TOP IS OBSERVED. BUT AT PRESENT FOUND DRY.

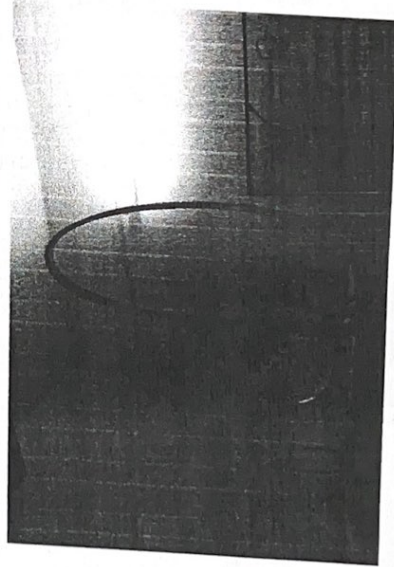
1. B- MINOR CRACK ON LOAD BEARING WALL IS OBSERVED.

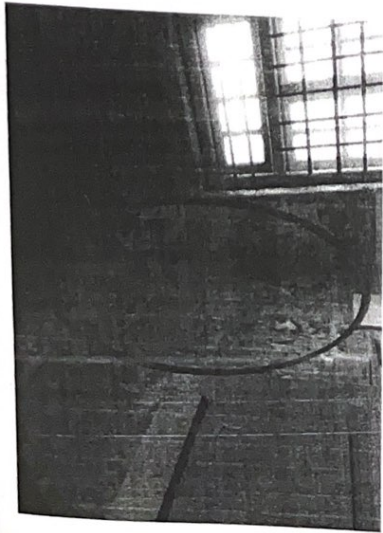
2. B- EXTERNAL SEEPAGE WITH DEEP MASONRY CRACKS IS FILLED WITH CEMENT MORTAR.

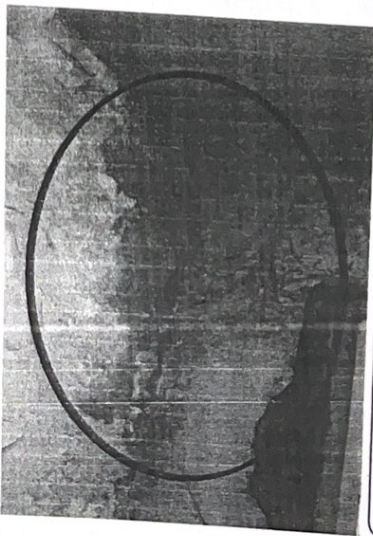
2. B-SEVERE EXTERNAL SEEPAGE IN CEILING IS OBSERVED.

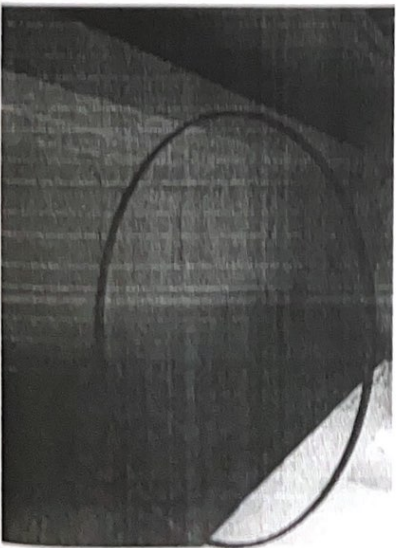
1.A- CEILING SHOWS DELAMINATION EFFECTS.

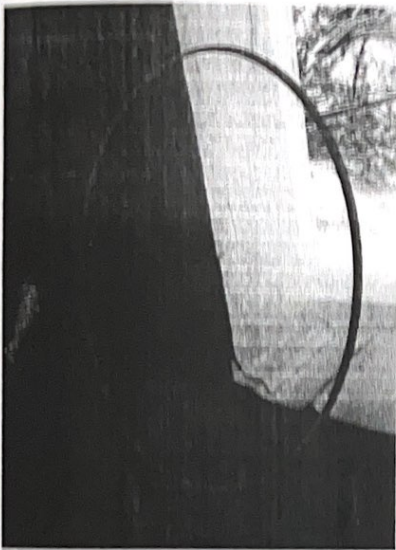
1.A- RC CRACK DEVELOPED IN THE R.C.C. BEAM CORNER.

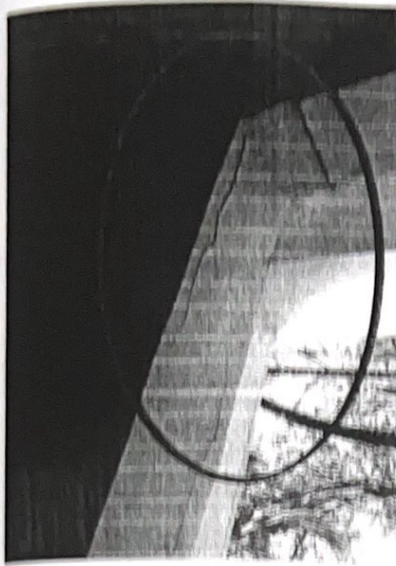
1.A- RC CRACK DEVELOPED IN THE R.C.C. BEAM

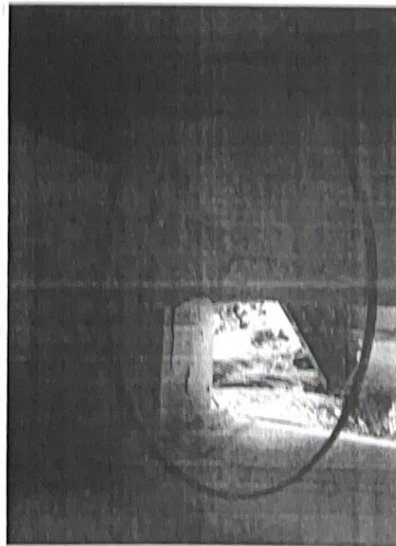
1.A- VERTICAL CRACK IN LOAD BEARING WALL MASONRY IS OBSERVED.

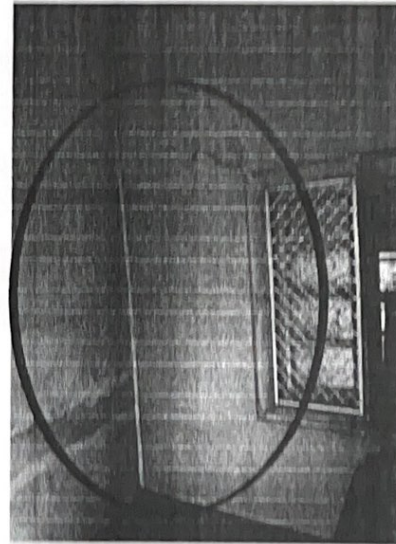
1.A- VERTICAL CRACK DEVELOPED IN LOAD BEARING WALL MASONRY WALL.

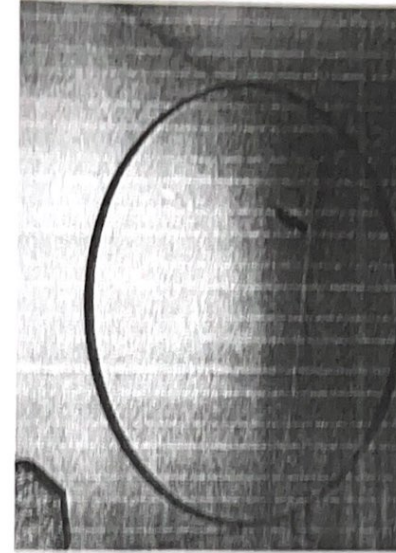
1.A- CEILING SHOWS DELAMINATION EFFECTS.
