# ***STRUCTURAL AUDIT REPORT***

**INDIA HOUSE NO:-1.**

***India House Compound,Kemps Corner,  
AK Marg,Grant Road, Mumbai.***

**30<sup>th</sup> June, 2023.**

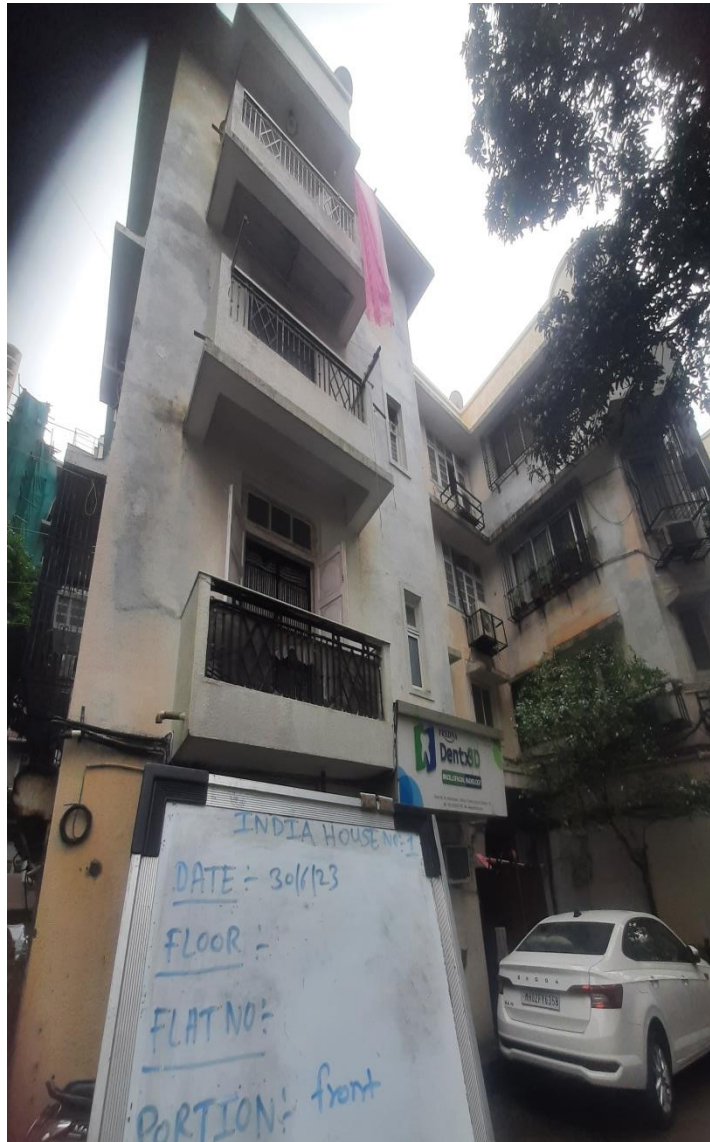
**ii) Plaster**

**External plaster of the building is seen in good condition.**

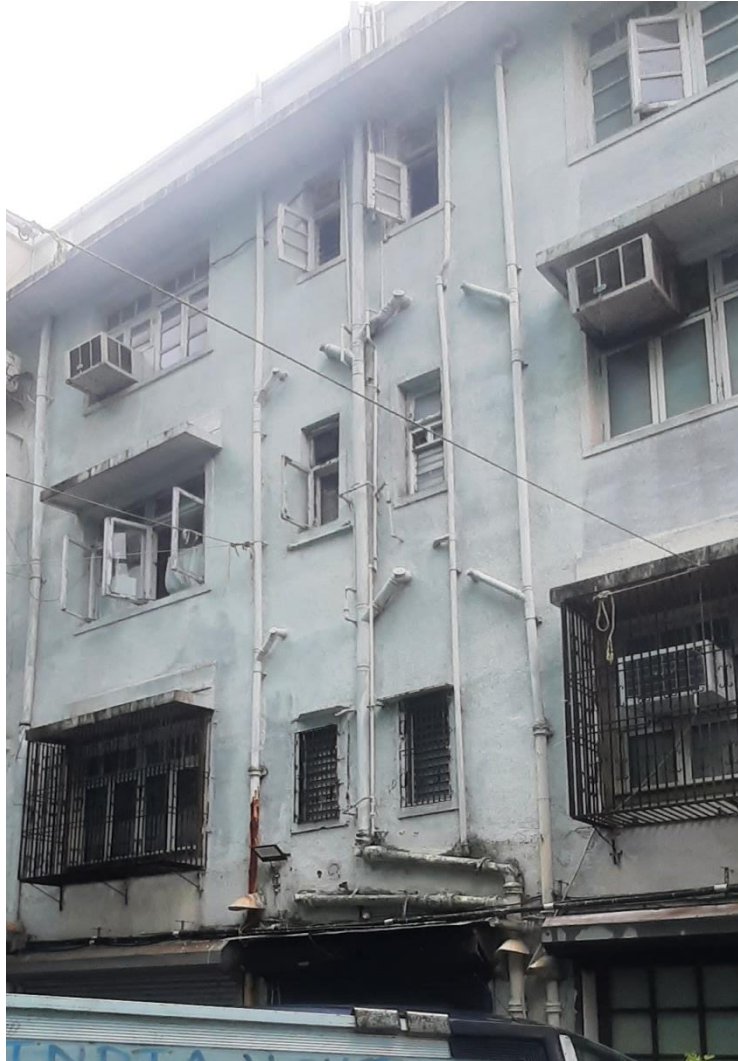
**ii) Drainage/Plumbing Line**

**Drainage/plumbing lines are seen in good condition.**

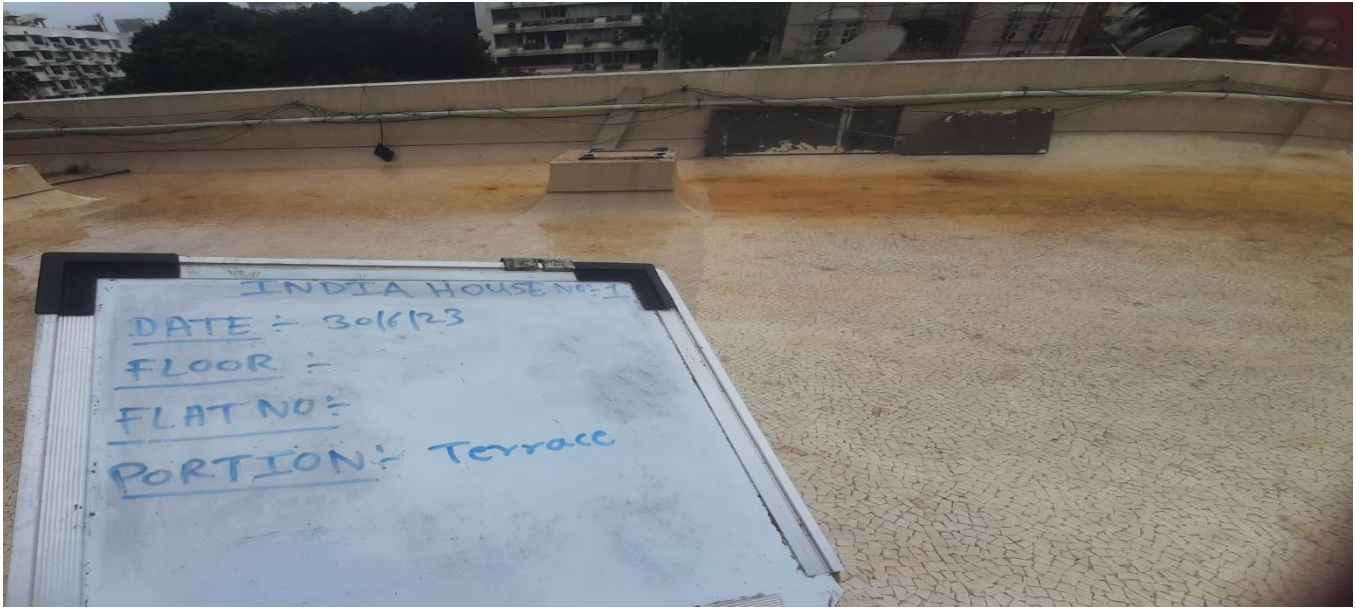
Terrace View

iv) Waterproofing Work  
Flooring need repairs.
