Vastu/Mumbai/11/2024/12433/2309100

Date: 18.11.2024

### Structural Stability Report

Structural Observation Report Residential Flat No. 503, 5<sup>th</sup> Floor, Building No. 4, Wing - A, "Himalaya", Om Jalaram Co-Op. Hsg. Soc. Ltd., Asha Nagar, Village - Poisar, Kandivali (East), Taluka - Borivali, District - Mumbai Suburban, Mumbai, PIN - 400 101, State - Maharashtra, India.

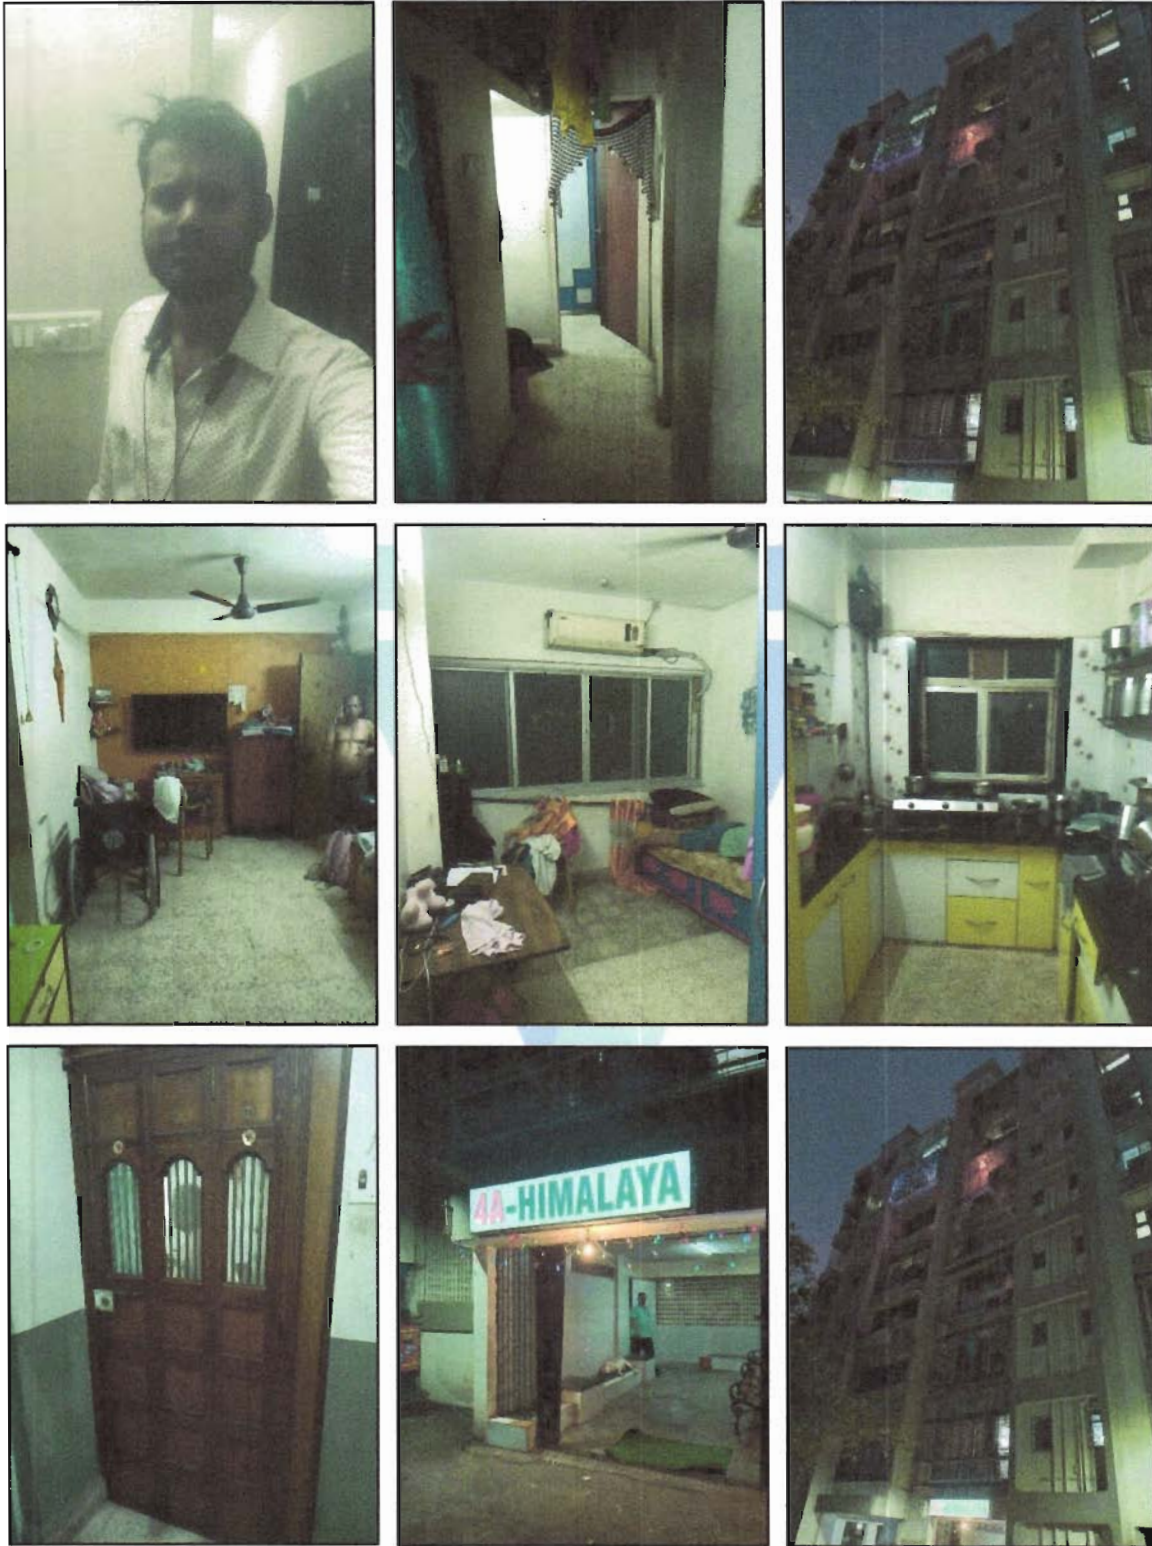
## Actual site photographs

B.	External Observation of the Building	
1	Plaster	Normal Condition
2	Chajjas	Normal Condition
3	Plumbing	Normal Condition
4	Cracks on the external walls	Found
5	Filling cracks on the external walls	Not Found
6	Cracks on columns & beams	Found
7	Vegetation	Yes

8	Leakages of water in the drainage pipes or water pipes	Yes
9	Dampness external in the wall due to leakages	Yes
10	Any other observation about the condition of external side of the building	Structural Stability Report from licensed structural engineers not provided for our verification.
<b>C Internal Observation of the common areas of the building and captioned premises</b>		
1	Beams (Cracks & Leakages)	Yes
2	Columns (Cracks & Leakages)	Not Found
3	Ceiling (Cracks & Leakages)	Not Found
4	Leakages inside the property	Not Found
5	Painting inside the property	Normal
6	Maintenance of staircase & cracks	Normal

<b>E</b>	<b>Conclusion</b>
<p>The captioned building is having Stilt + 7 Upper Floors which are constructed in year 1989 (As per occupancy certificate). Estimated future life under present circumstances is about 25 years subject to proper, preventive periodic maintenance &amp; structural repairs.</p> <p>The inspection dated 15.11.2024 of building. The building is well as the property is maintained in normal condition &amp; will stand future life subject to proper, preventive periodic maintenance &amp; normal structural repairs.</p> <p>Our Observations about the structure are given above.</p> <p>The above assessment is based on visual inspection only. Separate structural audit from licensed structural engineers is advised to assess exact balance life of structure.</p>
