BOM1 Monthly Progress Report

14th May 2024

01 Project Summary

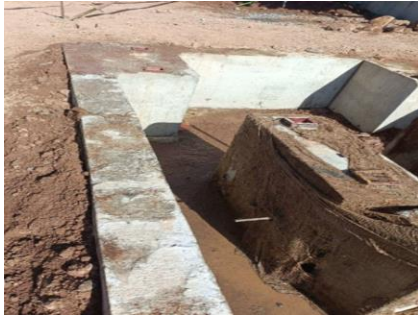
| Sr.no. | Observation | Location | Photo | Recommendation |
|---|---|---|---|--|
| 2 | Undulating and improper finishing on top of the wall Date: 06.05.2024 | Transformer Dyke Wall | | Top surface shall be finished levelled. KEC to propose corrective methodology using bonding agent. |

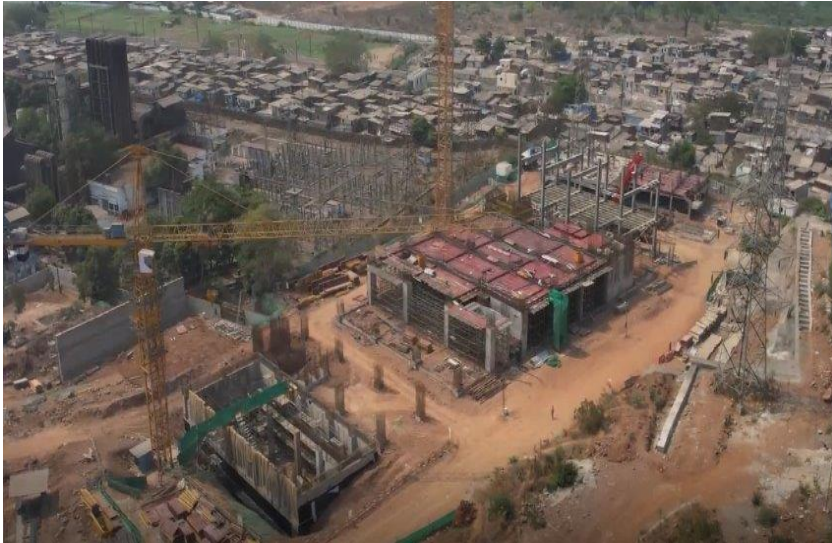
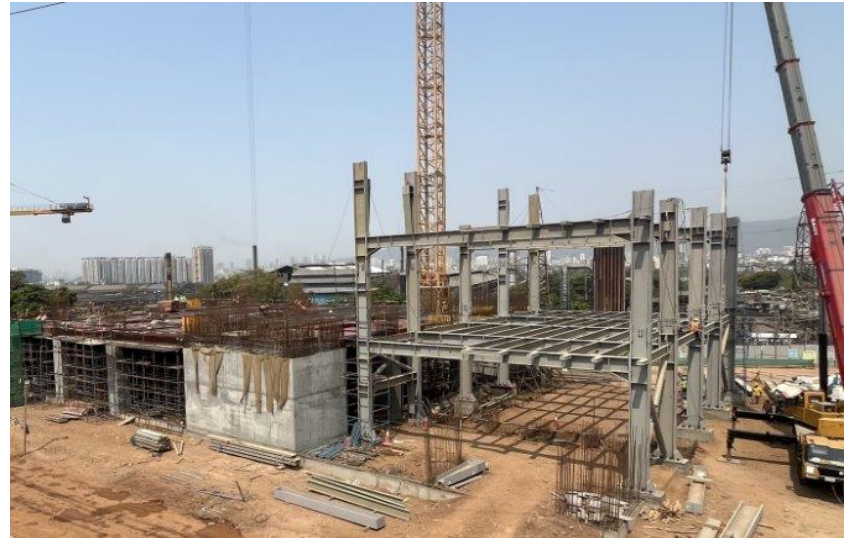
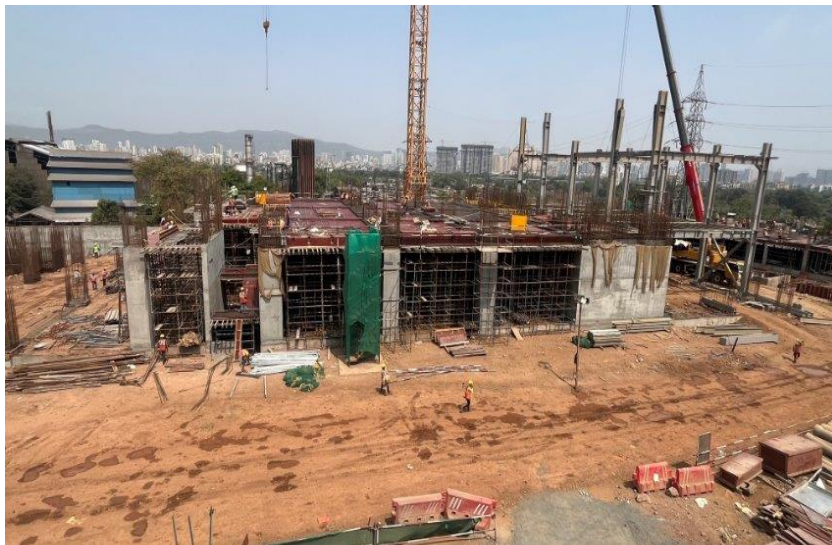
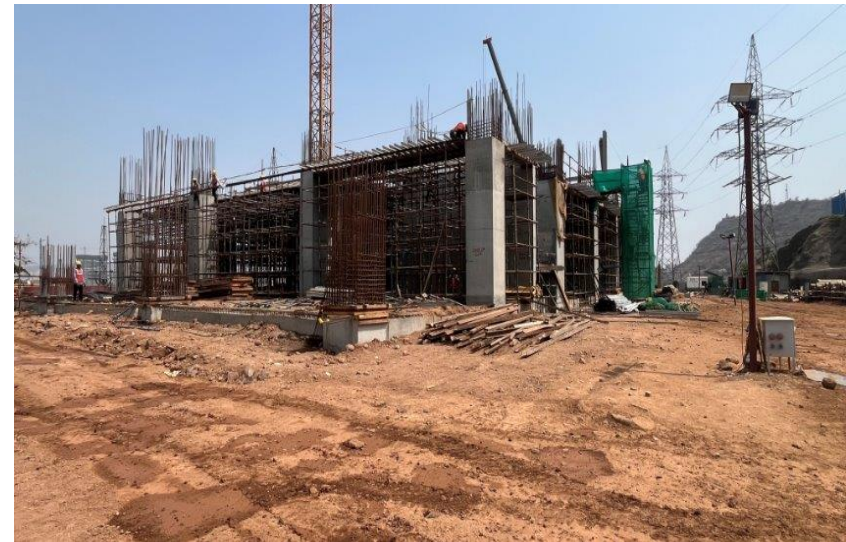
On Site Works – 30 Apr 24

DG – Substructure (A-B), DC – Substructure (C-L) and GIS

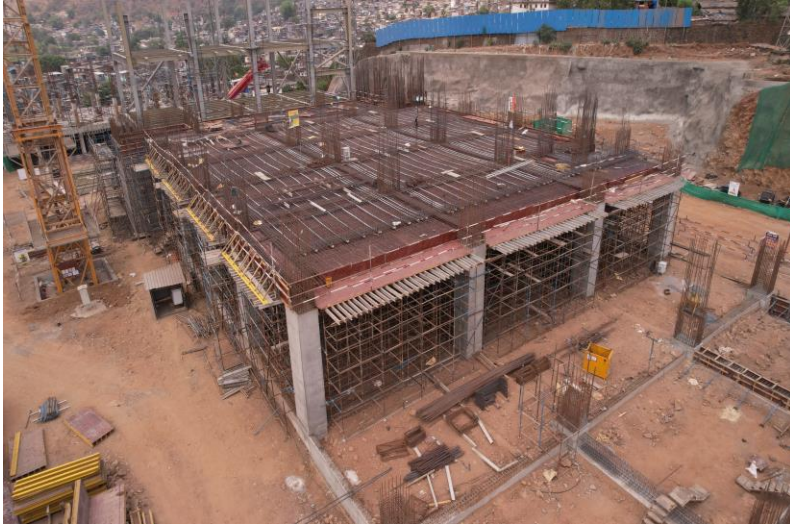
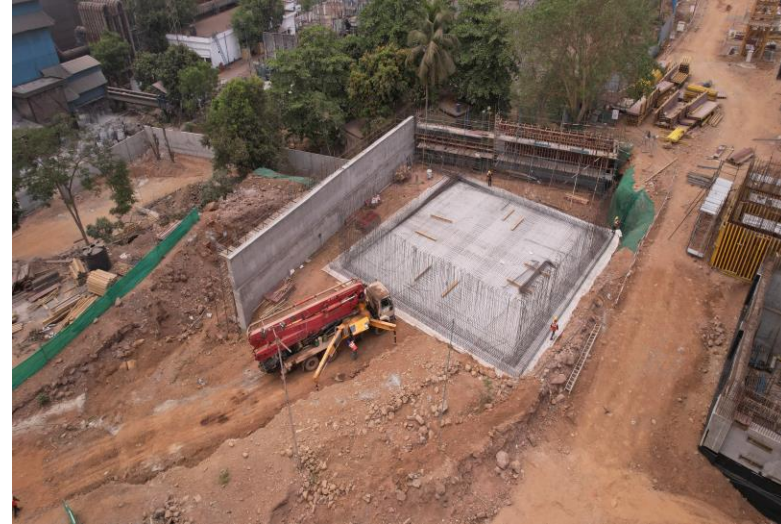
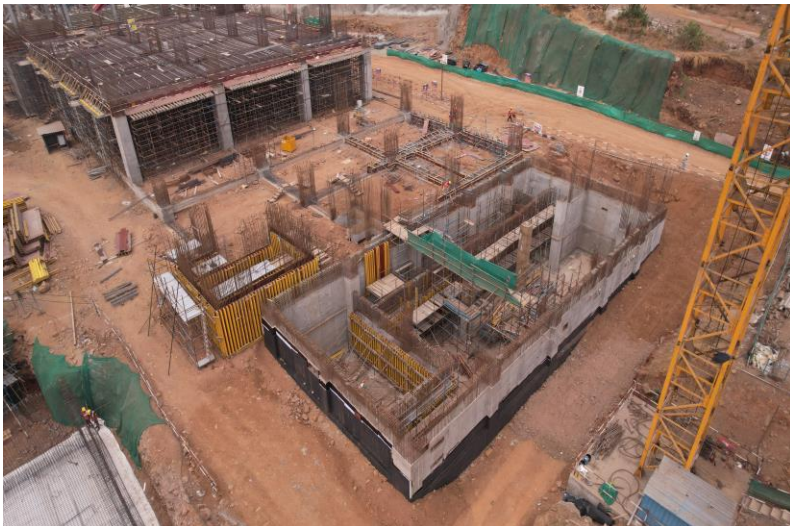
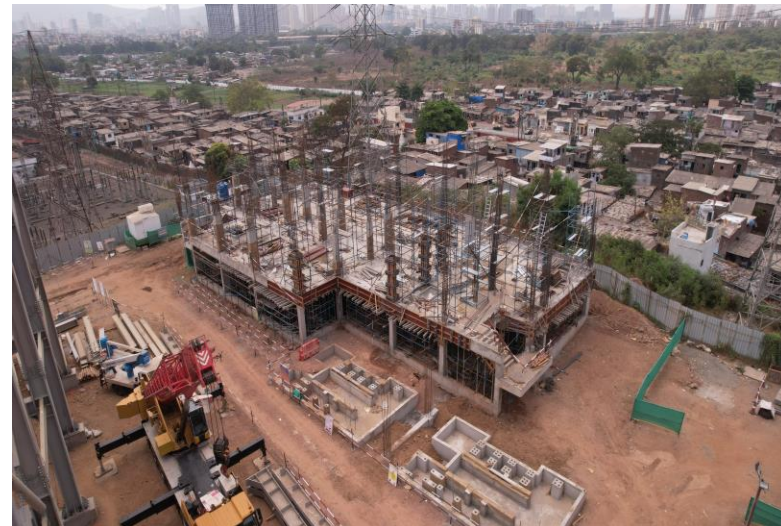
On Site Works – May 24

DC – Substructure (C-L) , DG – Substructure (A-B) and GIS substructure
