# STRUCTURAL AUDIT REPORT OF

## CHANDRA BHUVAN CO-OP HSG. SOCIETY Chandralok-A, 97, Nepean Road, Mumbai 400026

**A. D. SHINTRE CONSULTANS**  
ARCHITECTS & CONSULTING ENGINEERS

12.12.2019

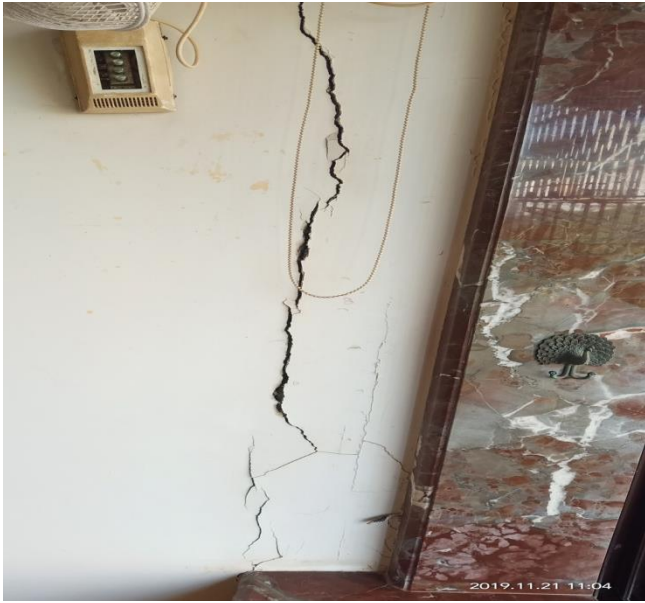
**Flat No.503: vertical cracks on living room column**

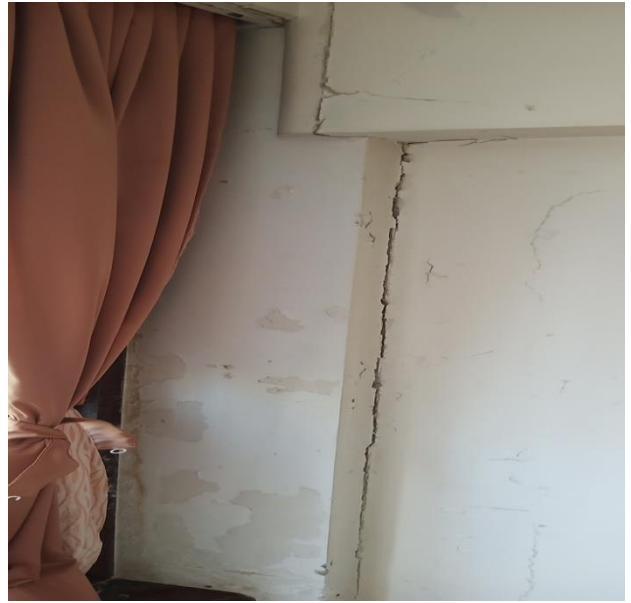
**Flat No.503: Cracks on living room column**

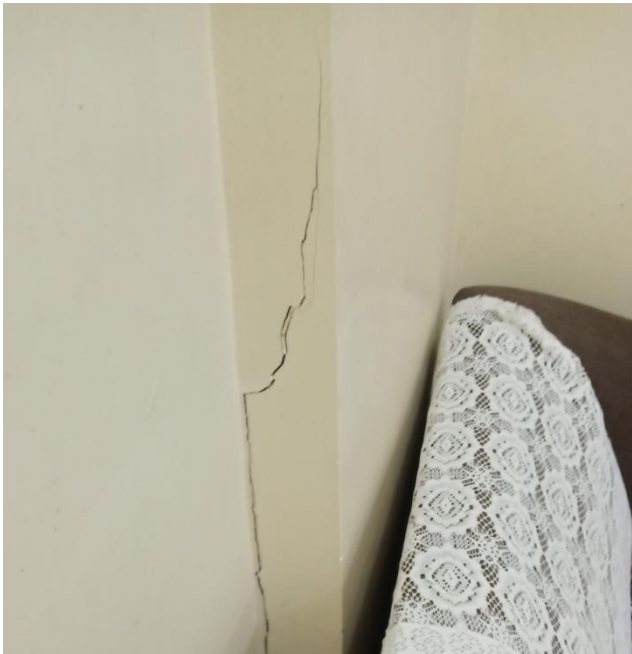
**Flat No. 110: Cracks on on column at livingroom**

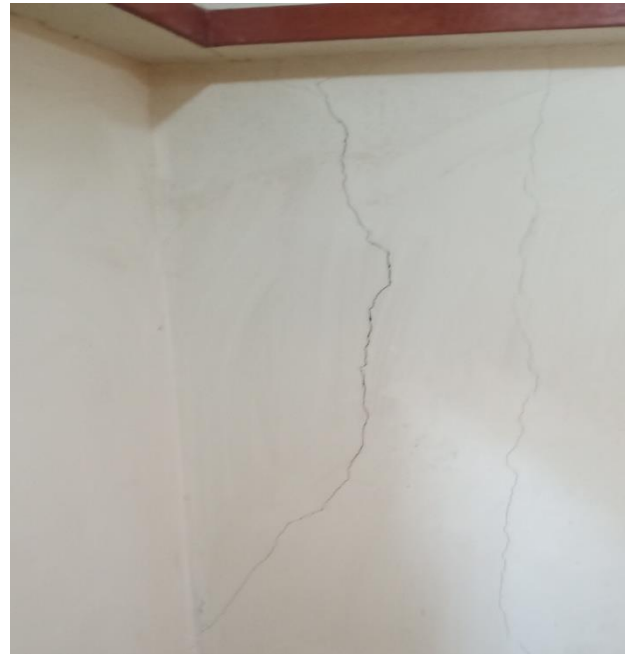
**Flat No. 110: Cracks on on column at bedroom**

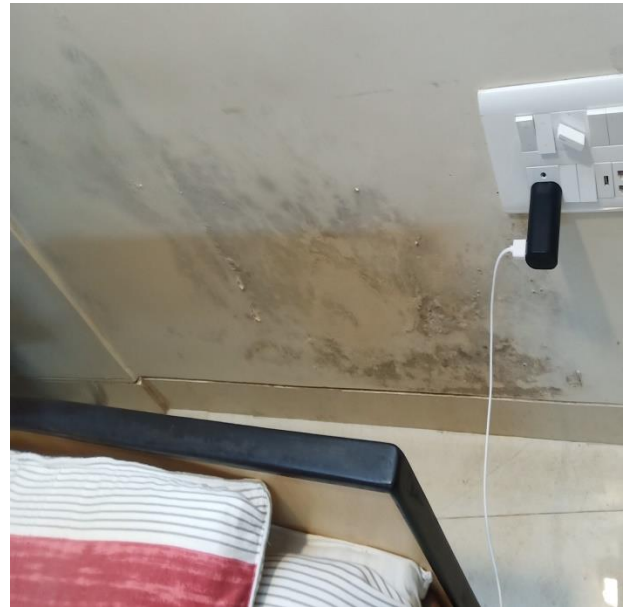
**Flat No. 105: Leakages marks on wall at bedroom-2**

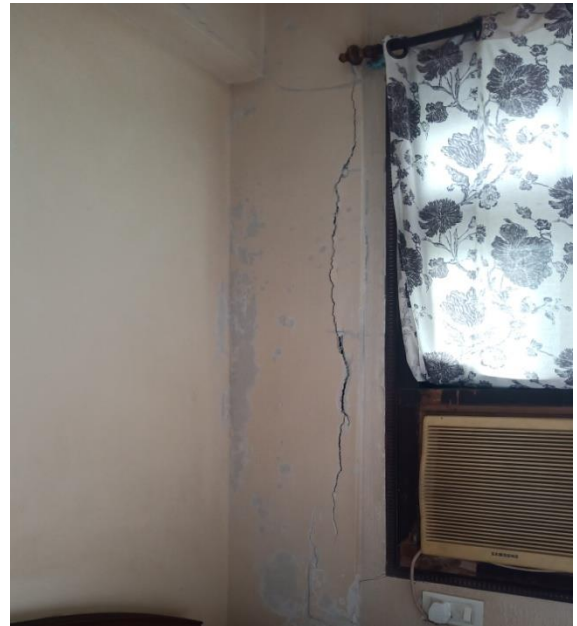
**Flat No. 205: Wide cracks on column at bedroom -3**

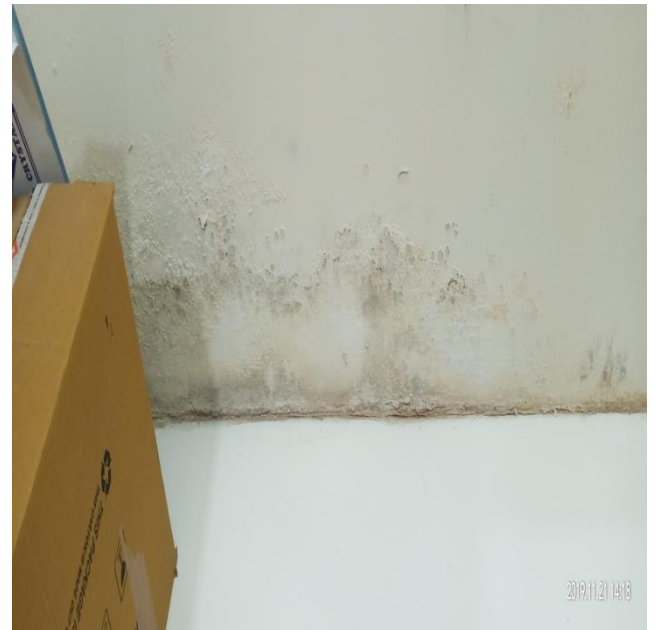
**Flat No. 204: Leakage marks on partition wall at Children room**

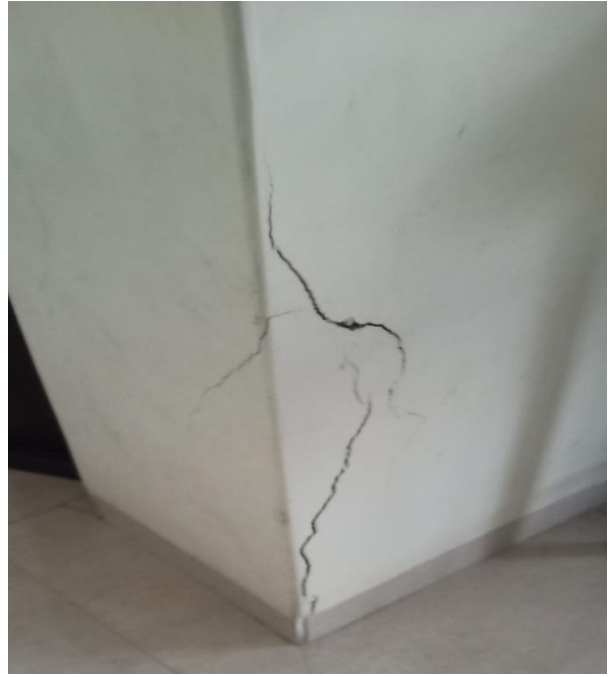
**Flat No. 205: Wide cracks on column at livingroom**

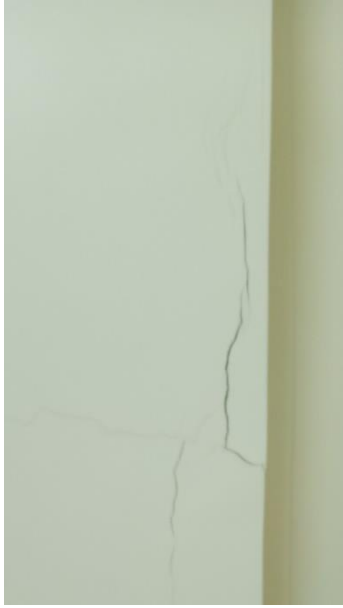
**Flat No. 207: cracks on column**

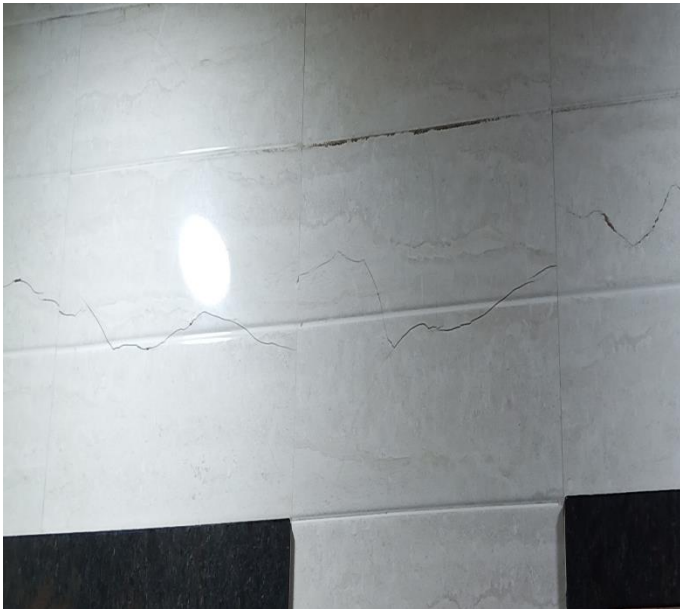
**Flat No. 304: Tiles cracks on beam at kitchen**

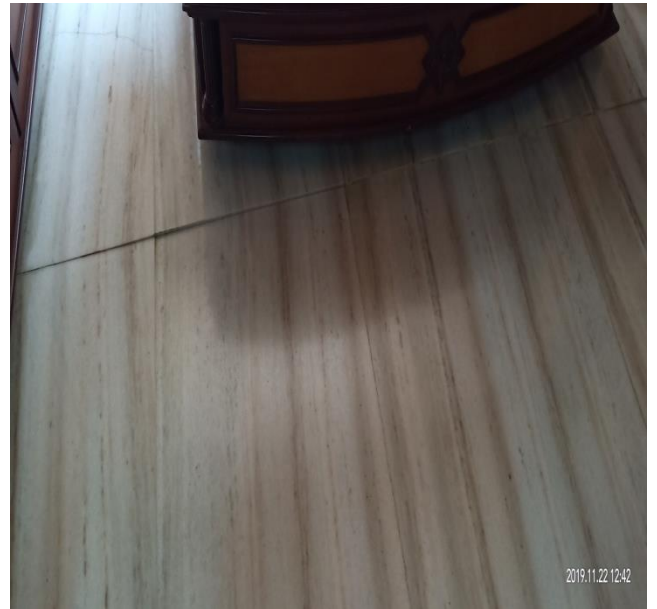
**Flat No. 306: Raised on flooring at bedroom**

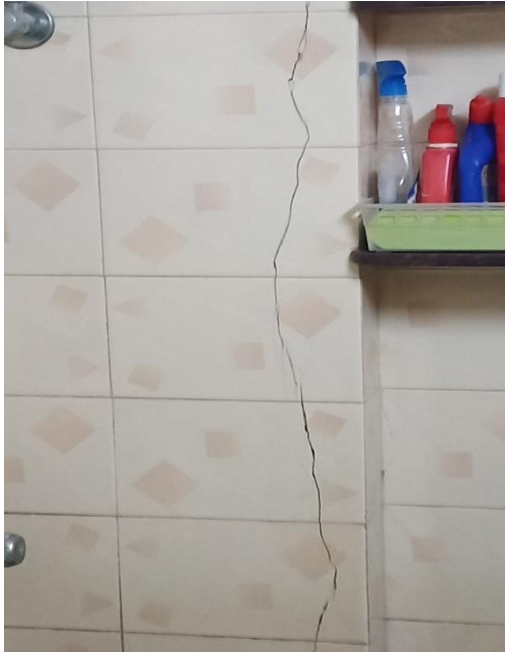
**Flat No. 306: Tiles cracks on column at bathroom**

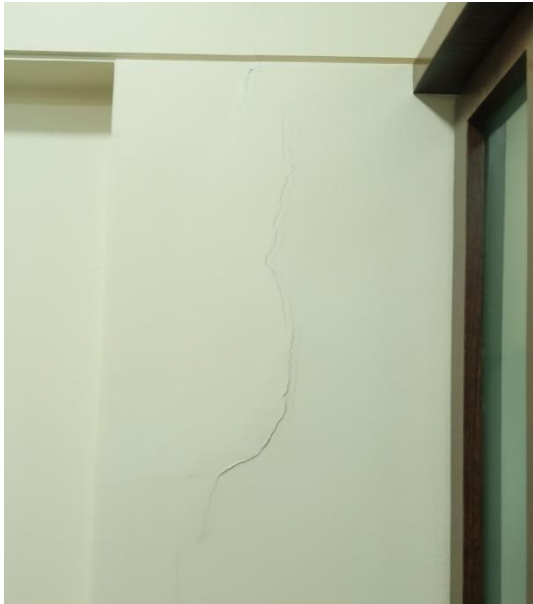
**Flat No. 111: cracks on column**

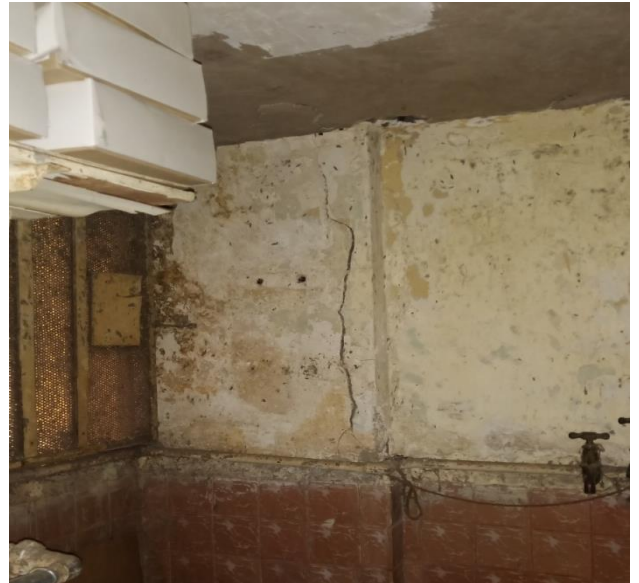
**Flat No. 307: Cracks on column at bathroom**

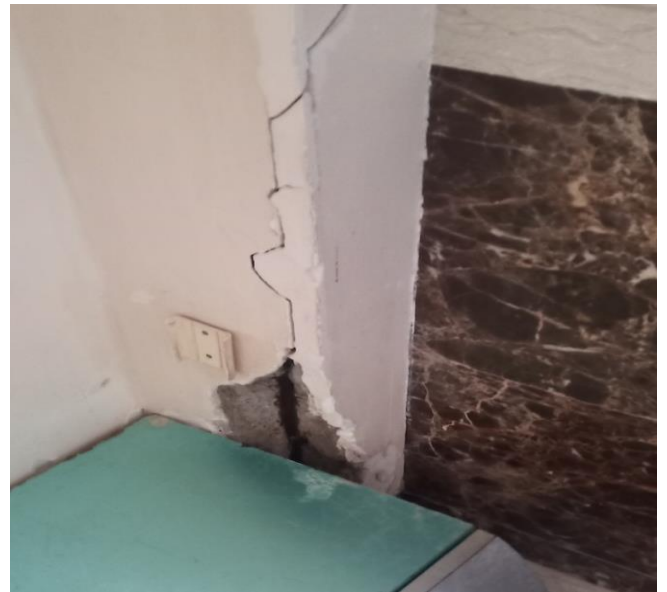
**Flat No.502: wide cracks on column at bedroom-1**

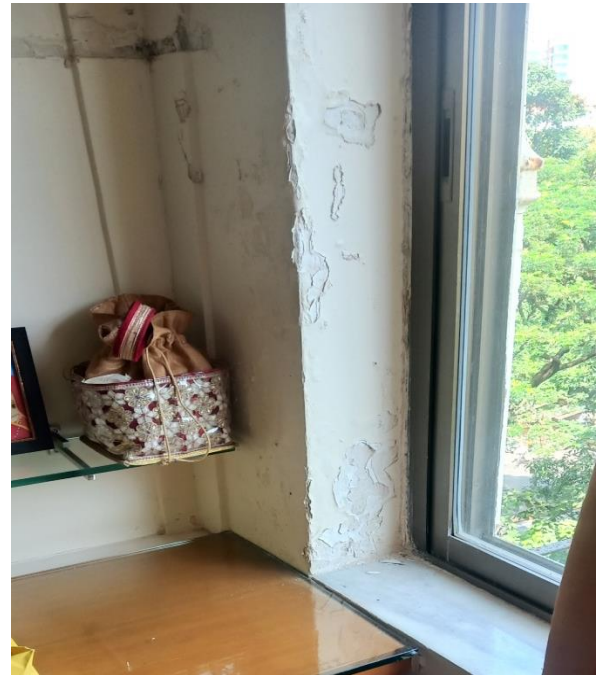
**Flat No.510: leakage marks on external wall**

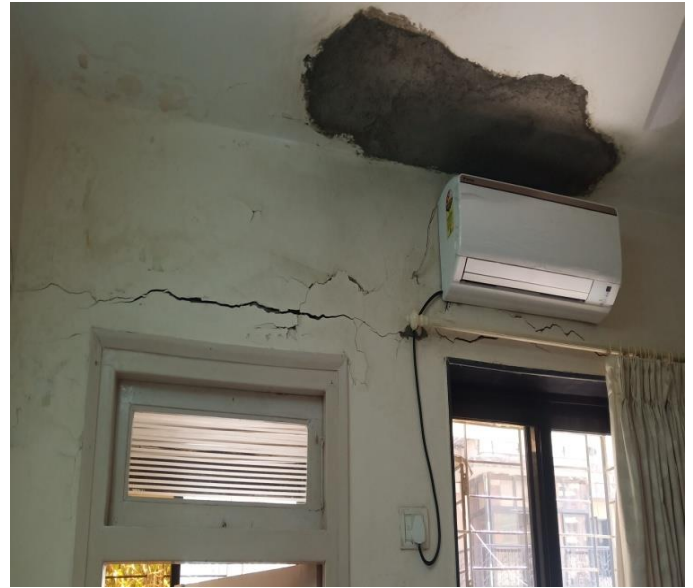
**Flat No.508: cracks on beam bottom**

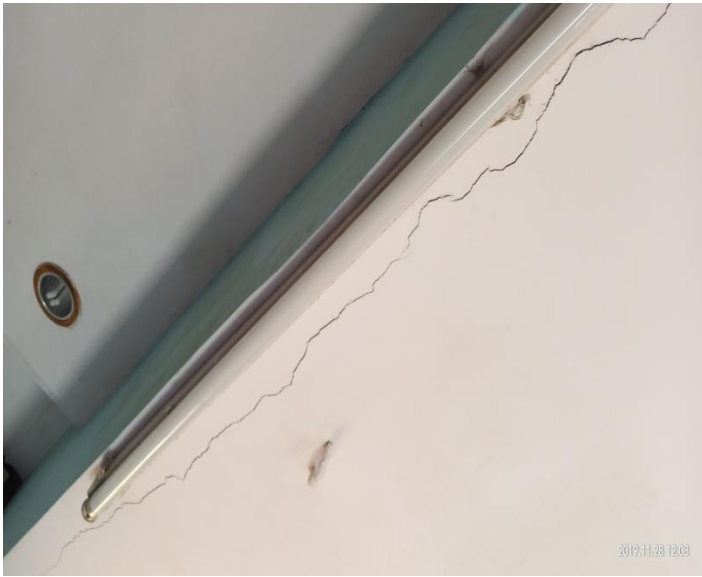
**Flat No.506: cracks on beam bottom**

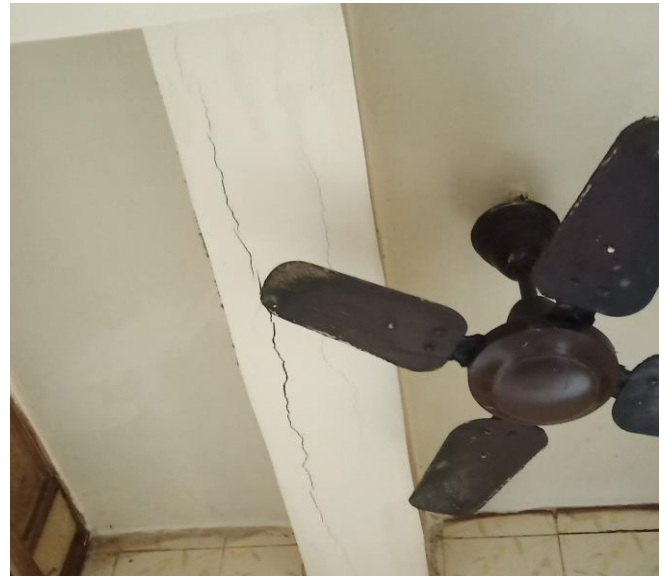
**Flat No.506: cracks on beam bottom**

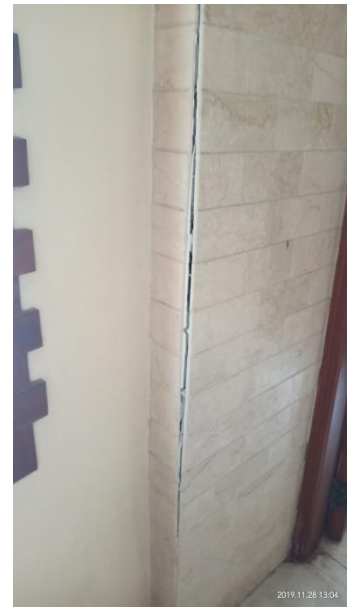
**Flat No. 104: Tiles cracks on column**

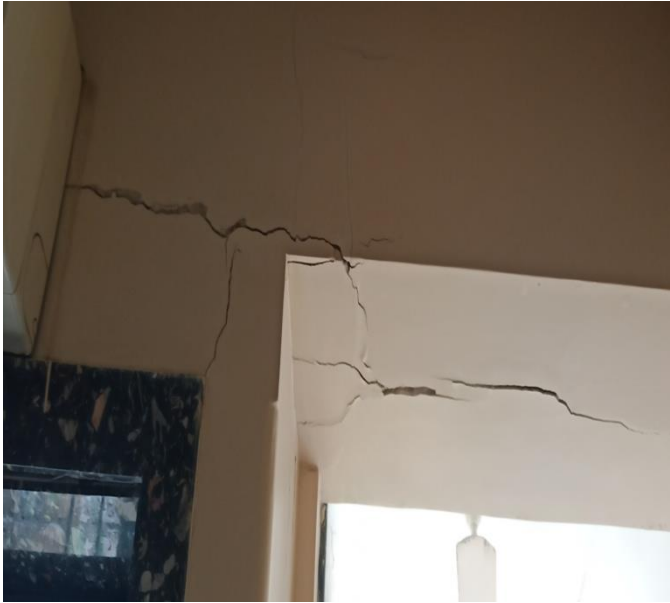
**Flat No.408: cracks on beam at bedroom-2**

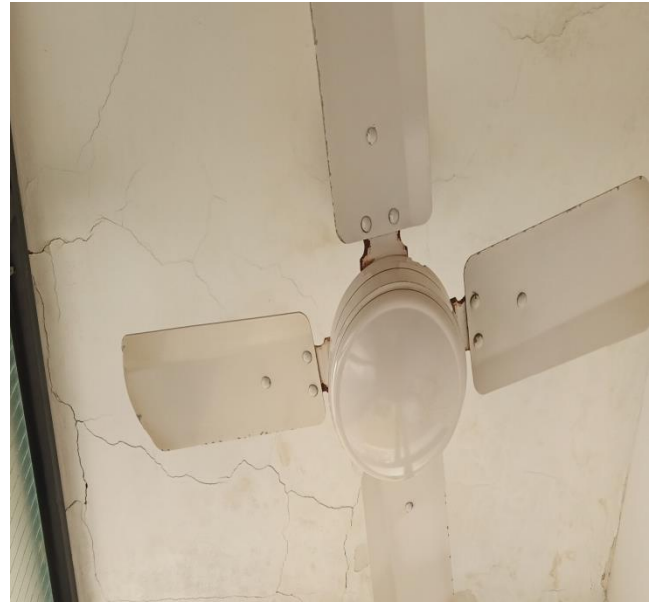
**Flat No.408: cracks on ceiling**
