# STRUCTURAL AUDIT REPORT OF

## CHANDRA BHUVAN CO-OP HSG. SOCIETY Chandralok-A, 97, Nepean Road, Mumbai 400026

**A. D. SHINTRE CONSULTANS**  
ARCHITECTS & CONSULTING ENGINEERS

12.12.2019

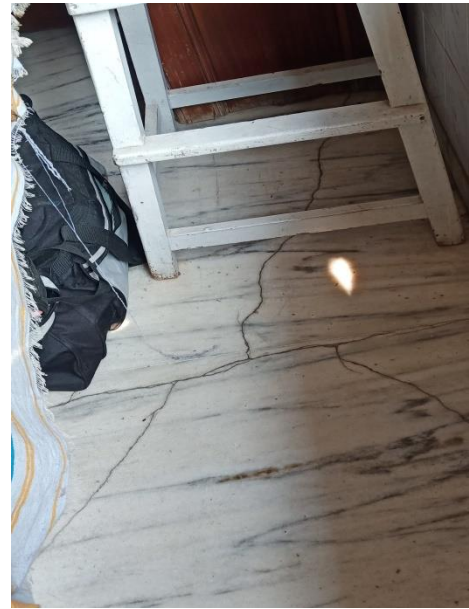
**Flat No. 409: cracks on floor tiles/stone**

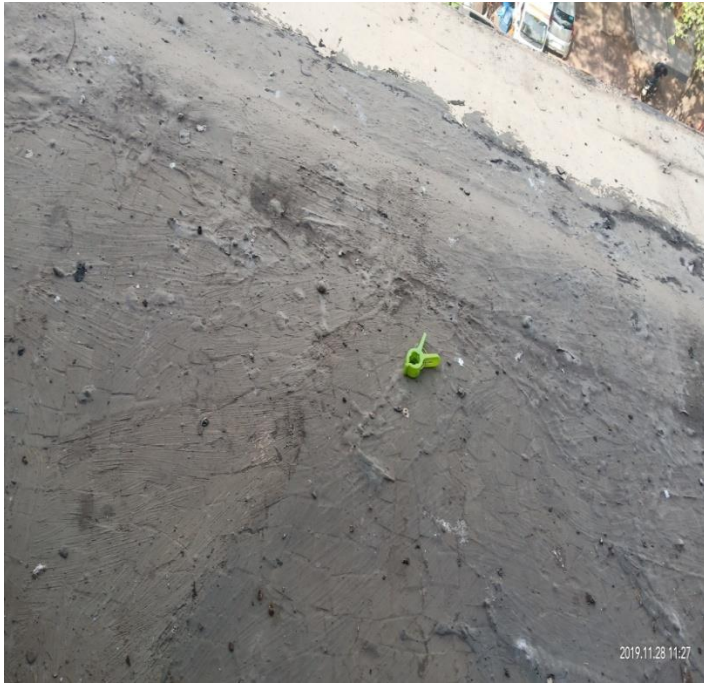
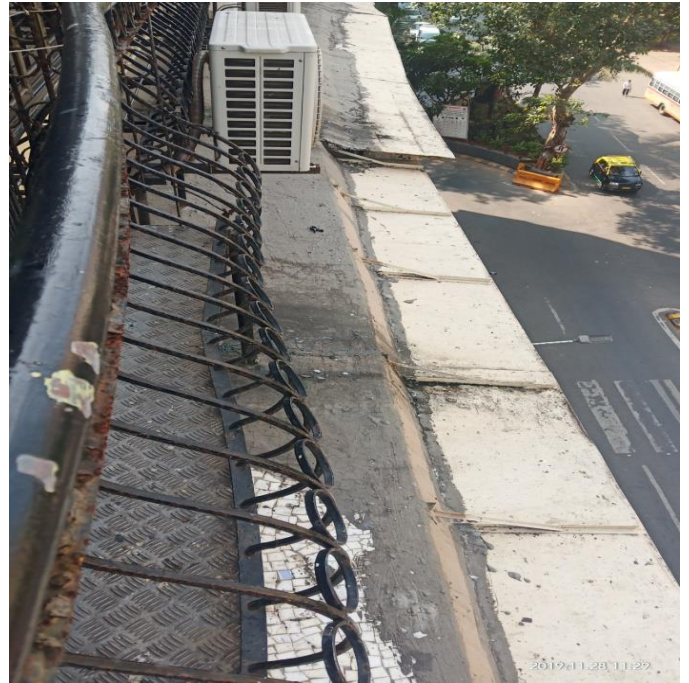
Chemical coatings and Membrane treatment are observed on balcony top terrace at 5<sup>th</sup> floor level.

**Water proofing coating on 5<sup>th</sup> floor level balcony top.**

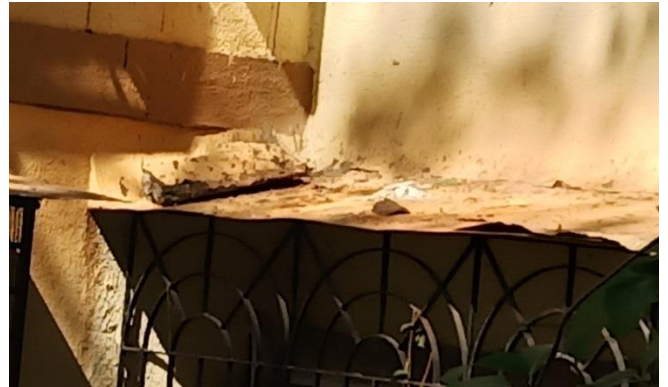
**Damage Vatta on weather shed**
